Professional Consultation Report

Provide Envelope Upgrades
Adirondack Park Agency Headquarters

1133 NYS Route 86
Ray Brook, NY

Project No. 46219

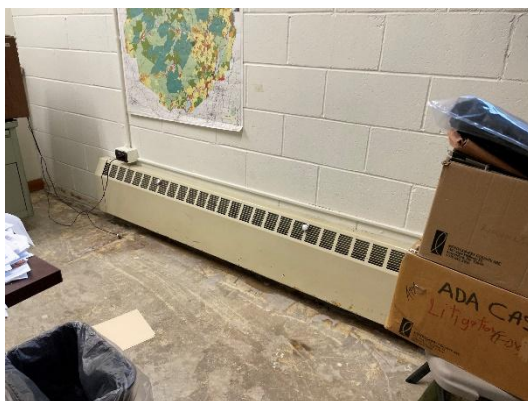
- F1) Basement Exterior Walls:** The original log cabin and 1990's addition foundation walls are concrete masonry units (CMU) exposed on the interior finish side as shown in **photo 1** below. According to the 2004 addition construction drawings, the exterior foundation walls consist of cast-in-place concrete walls with dampproofing applied on the exterior side and 1-inch rigid insulation and gypsum wall board on the interior finish side. The drawings for the 2004 additions do not indicate the installation of perimeter foundation drain.

It was reported by the Facility that the basement floor near the exterior walls, for the pre-2004 constructed walls, have on-going water infiltration issues that have required replacement of damaged carpeting. The Facility stated that water infiltration has only been observed at the base of the walls around the perimeter with no issues observed at the 2004 addition.

Photo 1 – Basement CMU Walls

No signs of water infiltration or damaged finishes were observed during the site visit. Based on the reported location of water infiltration it is assumed the infiltration is occurring at the joint between the CMU foundation wall and concrete footing.

- R1) Basement Exterior Walls:** To mitigate future issues with water infiltration through the exterior basement walls it is recommended to provide positive side waterproofing over the existing CMU with 2-inches of extruded polystyrene insulation down to the footing. This installation would meet the prescriptive requirements of the 2020 NYS Energy Code for an Alteration Level 1 Classification of Work. This is the recommended approach based on our understanding that this similar detailing was installed at the 2004 additions and there have been no issues with water infiltration into the basement.

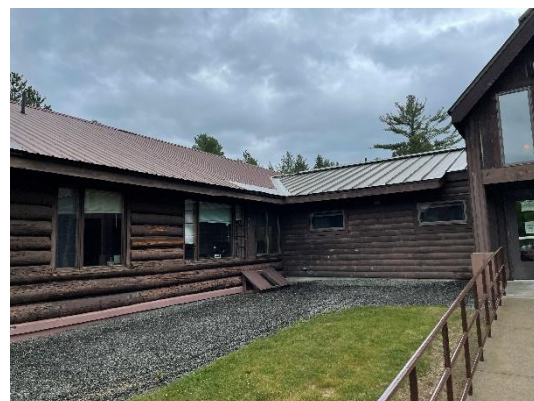
As part of the construction in 2004 project a waterproofing flexible membrane was laid beneath stone gravel around the perimeter of the original log cabin to help direct water away from the foundation drain around the perimeter and reduce the basement water infiltration issues. The typical extents are as shown in the below **photo 2**. This remedy has not been successful. In addition, circa 2004 perimeter EIFS (an exterior-insulation-finishing-system) was installed over the exterior foundation walls that were exposed above grade.

Photo 2 – Gravel Perimeter

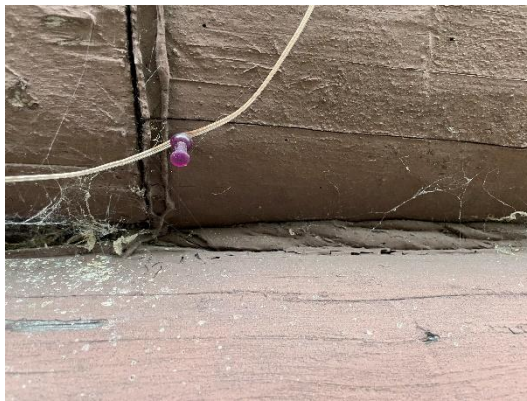
Chinking - The chinking material is in poor condition. Meaning it has been subjected to hard or long-term wear and is at, or near, the end of its useful or serviceable life. There have been numerous prior repairs that have since failed and several areas where daylight is visible from the interior and is highly susceptible to air/water/insect/rodent infiltration issues. There is approximately 1,500 LF of chinking material exposed to the exterior. See the below **photos 3 thru 6** of representative chinking material conditions.

Photo 3 – Exterior Chinking

- 1) **1970s Original:** Remove existing chinking material and existing paint system down to sound wood substrate. Provide new elastomeric chinking material on the exterior of logs, patch open splits with an epoxy wood filler material, and provide two coats of an exterior acrylic solid color stain. It is assumed that the log wood restoration with an epoxy filler would take approximately one labor hour per square foot. Incidental work includes providing paintable silicone sealant at intersections to adjacent materials and at re-entrant corners. Further examination of the deteriorated log will need to be performed by a structural engineer to determine the detailing needed for replacement during the Design Phase.

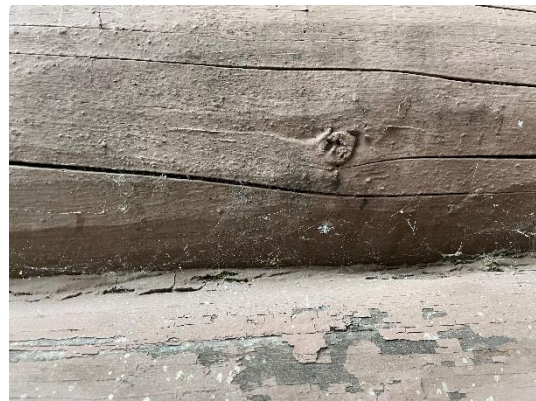
Photo 4 – Exterior Chinking

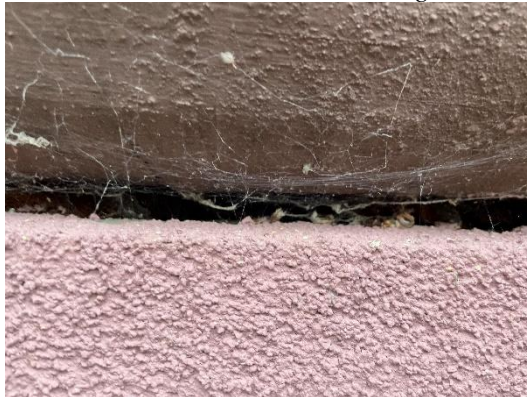
Photo 5 – Exterior Chinking

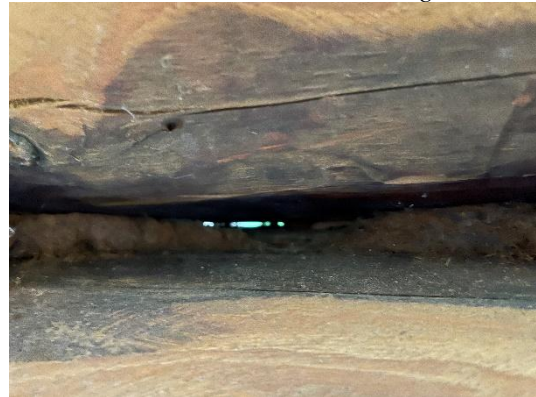
Photo 6 – Interior Chinking

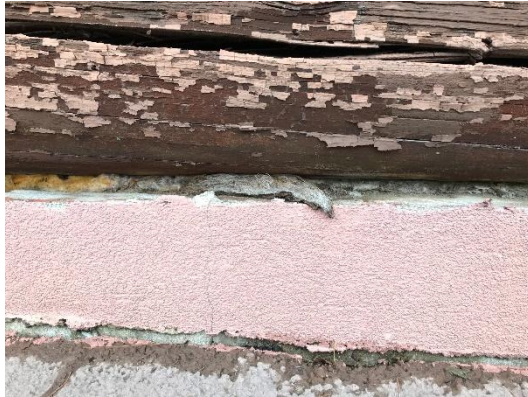
Logs - The logs are extremely weathered and are in poor condition. Meaning it has been subjected to hard or long-term wear and is at, or near, the end of its useful or serviceable life. There are numerous splits in every logs just above the foundation wall subject to the worse wear and tear. There is one section of log on the South elevation that has extreme rot and requires replacement. A portion of this deteriorated log was not visible during the site visit due to it being covered with sheet metal to prevent water from readily infiltrating into the building. The logs in their current condition are susceptible to water and insect infiltration that will result in continued accelerated deterioration. There is approximately 450 SF of logs exposed to the exterior. See the below **photos 7 thru 10** of representative log conditions.

Photo 7 – Split Log

- 2) **Log Replacement:** Site visit by Structural Engineer required to examine the deteriorated logs and the needed detailing and means and methods for replacement. This may require limited interior destructive removals on the interior to facilitate visual observations.

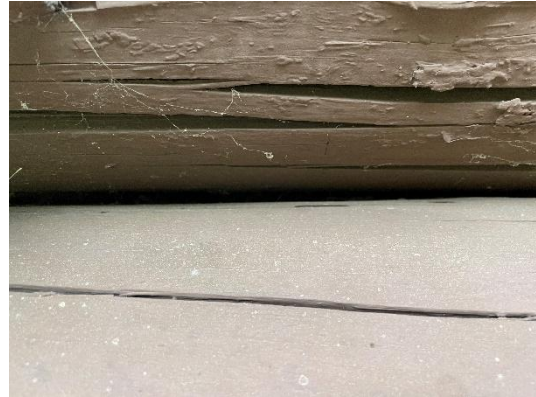
Photo 8 – Split Log

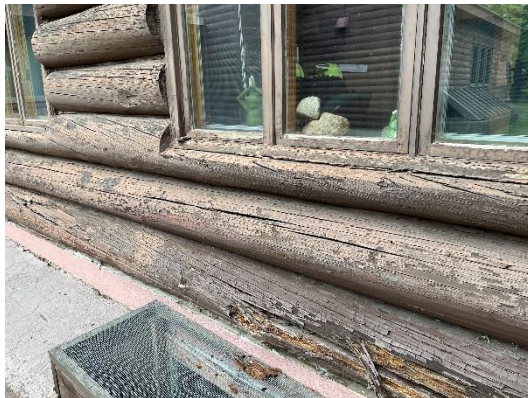
Photo 9 – Deteriorated Log

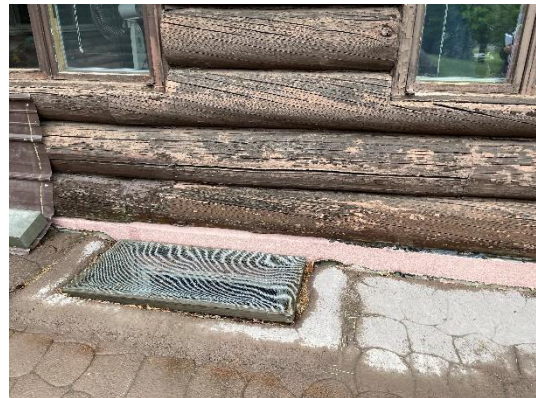
Photo 10 – Deteriorated Log

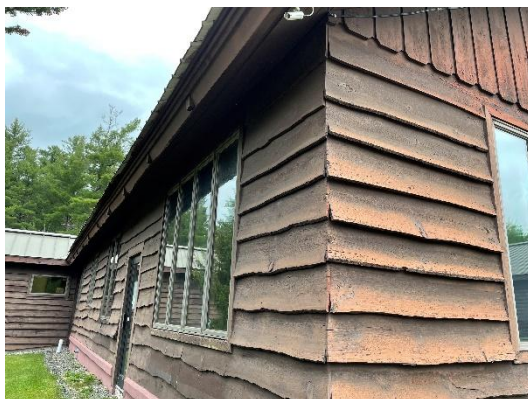
1990s Additions and 2004 North Addition: Rough sawn lap siding secured to vertical wood furring with polystyrene insulation installed between furring over black tar paper, with assumed concrete masonry unit back-up wall. The siding is extremely weathered and is in poor condition with the paint deteriorated and no longer providing protection against weathering. Meaning it has been subjected to hard or long-term wear and is at, or near, the end of its useful or serviceable life. There are portions of the siding with large openings, cupping of the siding is prevalent throughout, and a few areas with dry rot. The siding is highly susceptible to air/water/insect/rodent infiltration issues that will result in continued accelerated deterioration. There is approximately 2,700 SF of siding. See the below **photos 11 thru 14** of representative siding conditions.

Photo 11 – 90's Siding w/ Vertical at Gable

- 2) **1990s Additions and 2004 North Addition:** Remove rough sawn lap siding, wood furring and polystyrene insulation installed between furring down to the existing concrete-masonry back-up wall. Provide new T&G log siding to match the 2004 addition over furring and with extruded polystyrene insulation between furring. Assume existing air/water barrier over existing back-up wall is either non-existent or in need of replacement. Provide paintable silicone sealant at intersections to adjacent materials and at re-entrant corners, and two coats of an exterior acrylic solid color stain.
- 3) **2004 South Addition:** Provide paintable silicone sealant at intersections to adjacent materials and at re-entrant corners, and two coats of an exterior acrylic solid color stain.

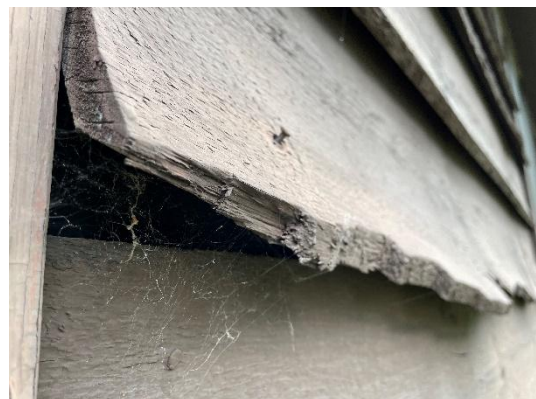
Photo 12 – 90's Siding w/ Severe Cupping

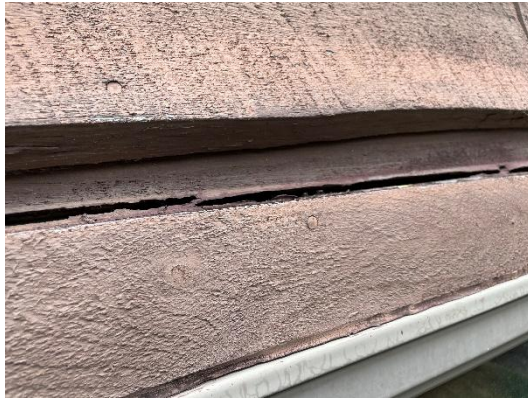
Photo 13 – Splitting Typical

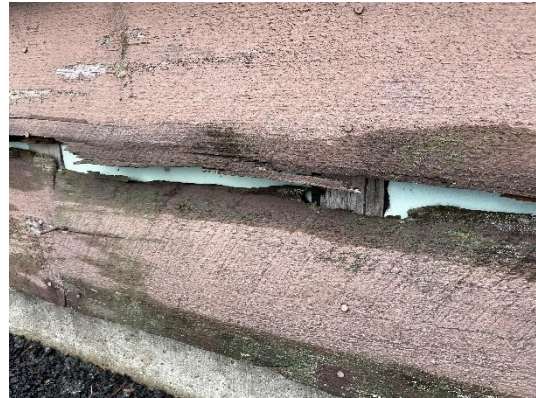
Photo 14 – 2004 Rot w/ Exposed Insulation

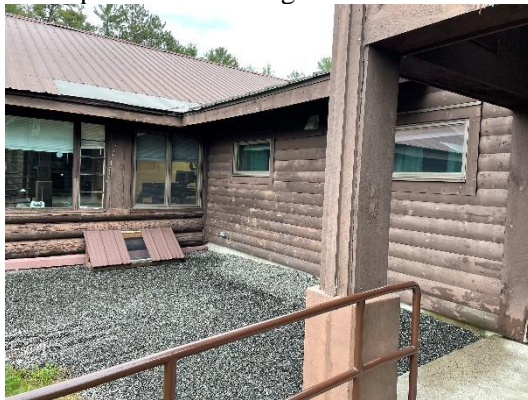
- 2) **2004 South Addition:** Tongue and Groove log siding, to replicate the original building, secured to stud wall back-up construction, and previously painted with a coating that has since failed. The siding is in serviceable condition and with the proper maintenance can continue to serve its function. There is approximately 1,500 SF of siding. See the below **photos 15 thru 18** of representative siding conditions.

Photo 15 – Log Siding to match Original

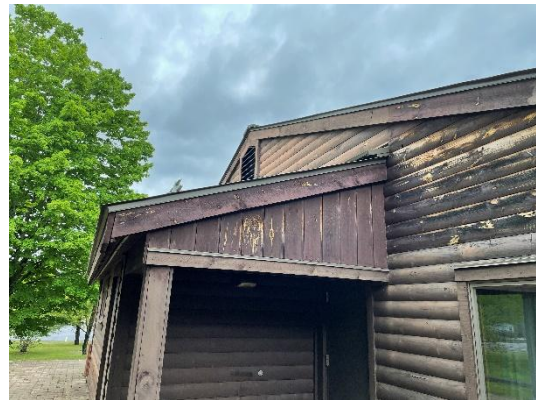
Photo 16 – Typical Condition

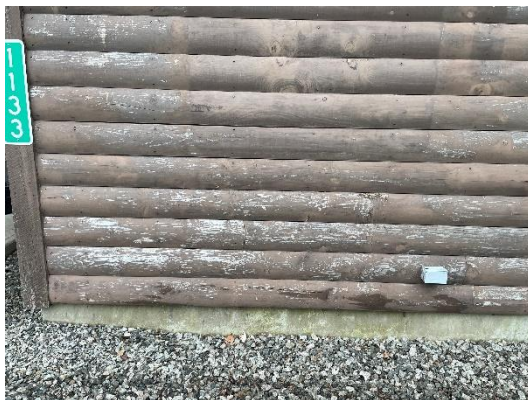
Photo 17 – Failed Paint Coating

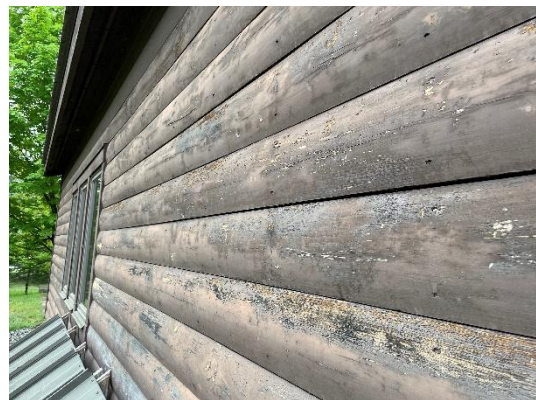
Photo 18 – Serviceable Condition

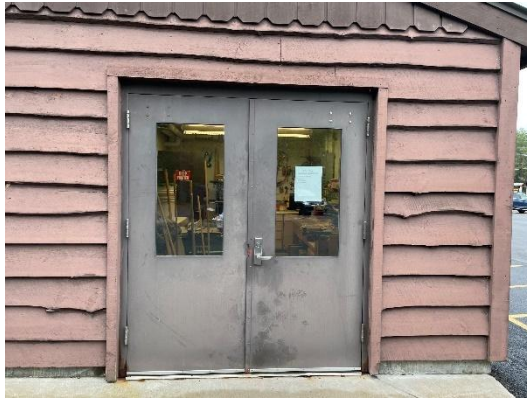
- 1) **Doors:** Combination of painted steel doors or aluminum with painted steel grouted frames. In most instances the steel frames are corroded on the bottom on both sides of the jamb and need replacement. See the below **photos 19 thru 22** of representative conditions.

Photo 19 – Corroded Steel Frame

- 1) **Doors:** Replace doors with fiber-reinforced plastic doors with aluminum frames. Remove existing trim surround and replace with PVC painted trim.

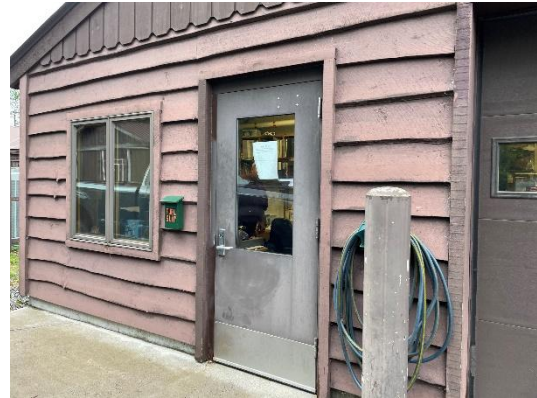
Photo 20 – Corroded Steel Frame

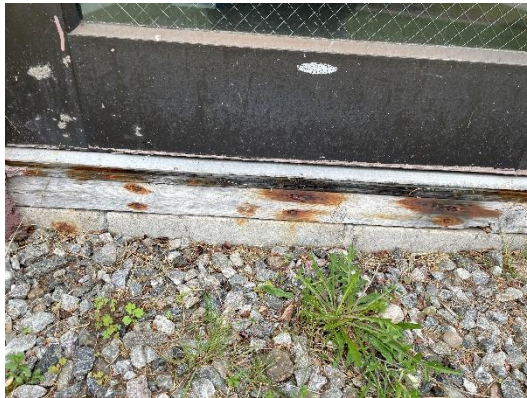
Photo 21 – Deteriorated Wood Sill

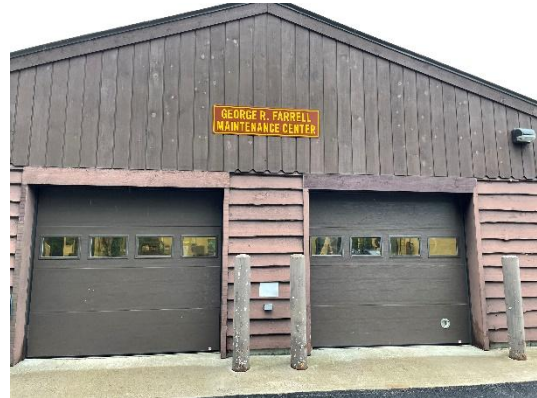
Photo 22 – Overhead Steel Doors

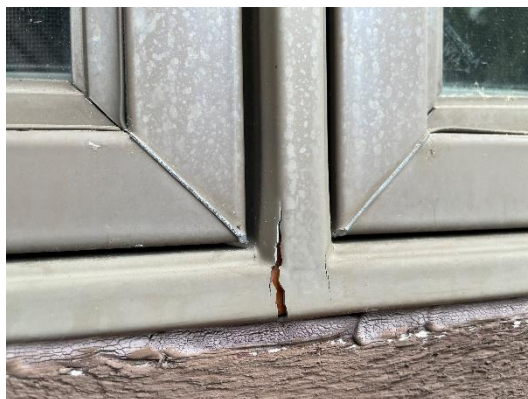
- 2) **Windows:** Combination of wood windows and vinyl clad windows depending on era of construction. The 1970s and 1990s windows have no sealant around the perimeter and no head or sill flashing, whereas the 2004 addition windows have head and sill flashing with deteriorated sealant around the perimeter of windows. In general, the windows are in poor to good condition depending on the location with an anticipated serviceable life up to 10 years. The windows without head or sill flashing have signs of water damage on the interior stained wood trim. See the below **photos 23 thru 26** of representative conditions.

Photo 23 – Cracked Cladding

- 2) **Windows:** Remove windows and replace anodized aluminum-clad windows with low-E double insulated glass. Where siding is being replaced extend flashing into openings and provide aluminum head and sill flashing with perimeter sealant at abutting materials. While the 2004 Addition windows are in good condition there is a small quantity and replacement is recommended so windows are uniform in appearance and included warrantied with the other windows throughout the building.

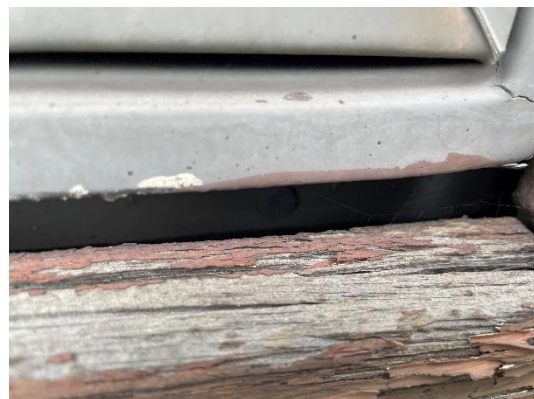
Photo 24 – No Sill Flashing or Sealant

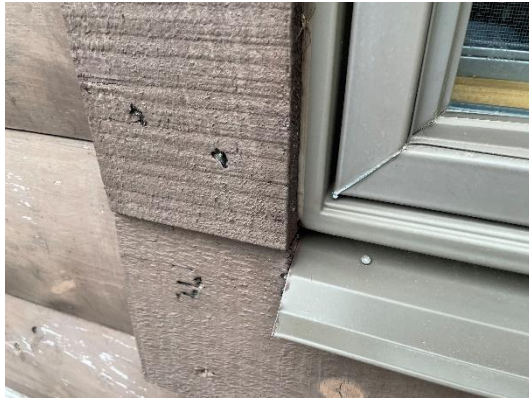
Photo 25 – 2004 Addition Typical

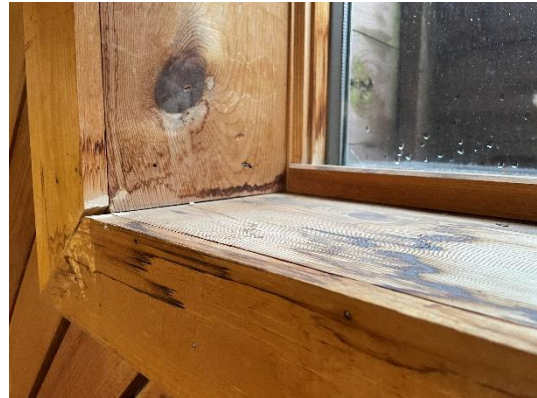
Photo 26 – Water Damage on Interior

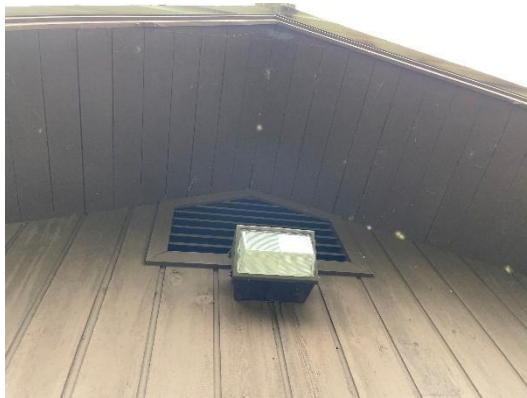
- 1) **Attic Vents:** Gable vents are located at each roof area with one location observed from within the attic to have a fan for mechanical ventilation, but other locations are assumed to only provide natural ventilation through convection. See the below **photos 27 and 28** of representative conditions.

Photo 27 – Typical Gabled Vent

- 3) **Vents:** Remove louvers and replace anodized aluminum louvers with insect screens and storm-resistant design. Where siding is being replaced extend flashing into openings and provide aluminum head and sill flashing with perimeter sealant at abutting materials.

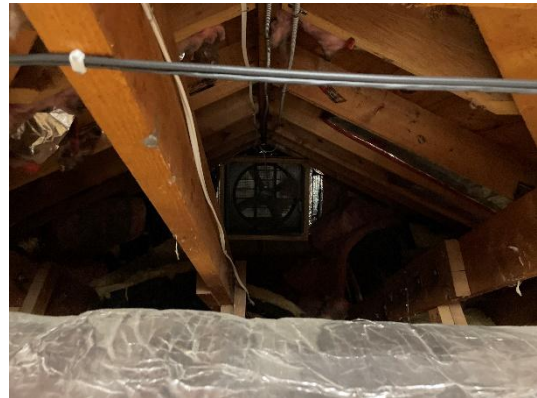
Photo 28 – Vent with Fan (Disconnected)

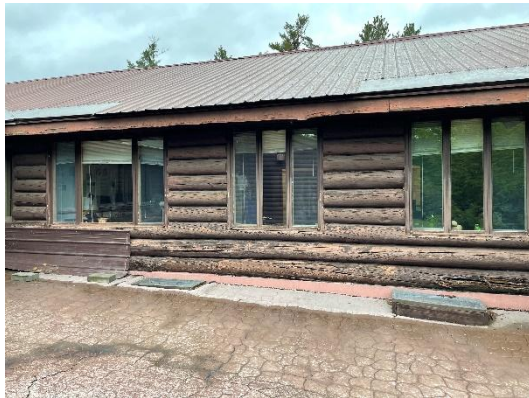
- 1) **1970s Original:** Corrugated sheet metal roofing with exposed fasteners. The Facility believes the metal roofing was installed over the original asphalt roof shingles. The attic space has insulation between the ceiling rafters with no insulation on the underside of the decking and no soffit venting. Observations were made from the ground where overall it appeared the sheet metal was in fair condition with no signs of water infiltration when observed from the attic space. However, the exposed fasteners are a concern for current and on-going points of water infiltration. Overall, the roofing system is nearing the end of its anticipated life expectancy with possibly 5 years of serviceable life remaining.

Photo 29 – 1970s Roofing

- 1) **1970s Original and 1990's Addition:** Remove the existing roof system(s) metal roof panels and original asphalt shingles and provide a new prefinished 24 gage galvalume non-structural metal standing seam roof system custom colored to match the 2004 Addition roof panels.
 - a. Alternative recommendations were considered as follows:
 - i. Fluid-Applied Coating - Provide a fluid-applied coating over the existing metal roof panels. The advantage is that this would result in less costs than a full replacement down to deck. The life expectancy would only be 10 years not providing the long-term solution desired by the Facility, and the finished appearance of the coating may not be desirable to the Facility.

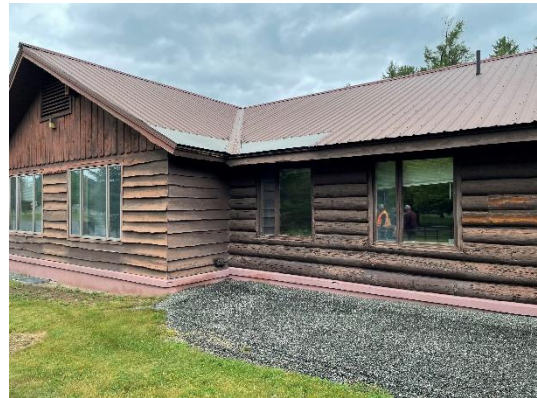
- 2) **1990s Additions:** Corrugated sheet metal roofing with exposed fasteners. The attic space has insulation between the ceiling rafters with no insulation on the underside of the decking with ridge vents and soffit vents provided. Observations were made from the ground where overall it appeared the sheet metal was in fair condition with no signs of water infiltration when observed from the attic space. However, the exposed fasteners are a concern for current and

on-going points of water infiltration. Overall, the roofing system is nearing the end of its anticipated life expectancy with possibly 5 years of serviceable life remaining.

Photo 30 – 1970s to 90s Valley

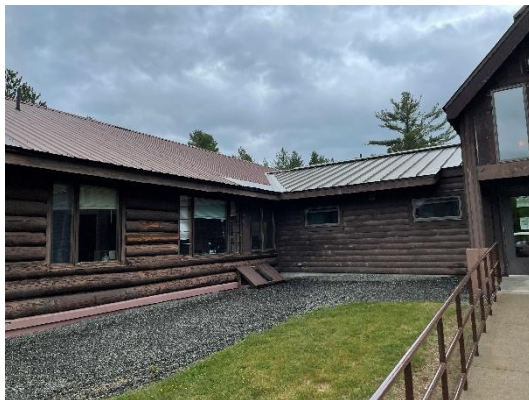
- 3) **2004 Additions:** Standing seam metal roofing with no exposed fasteners. The attic space has insulation between the ceiling rafters with no insulation on the underside of the decking with ridge vents and soffit vents provided. Observations were made from the ground where overall it appeared the sheet metal was in good condition with no signs of water infiltration when observed from the attic space. Overall, the roofing system is in serviceable condition with an anticipated life expectancy remaining of 15-20 years.

Photo 31 – 2004 Roofing

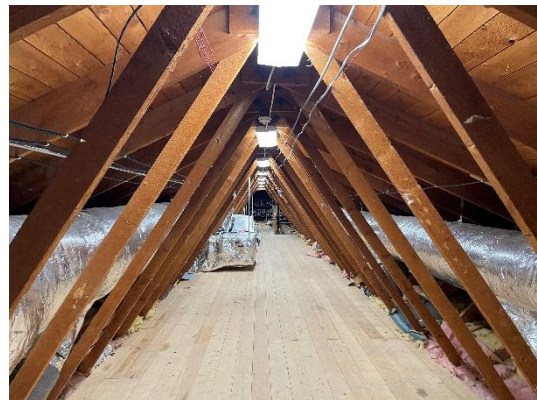
Photo 32 – Uninsulated/Vented Attic Space

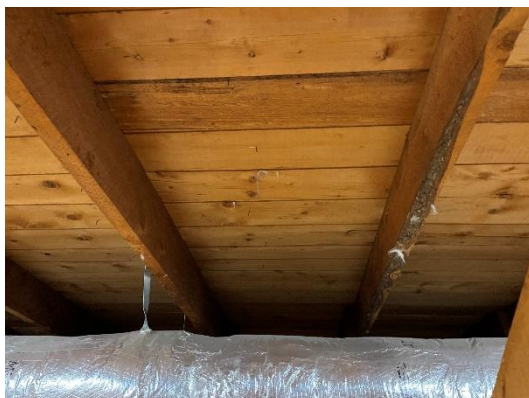
Photo 33 – Typical Deck Condition

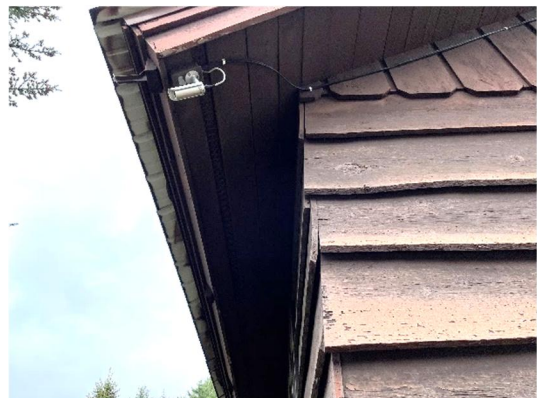
Photo 34 – Soffit Vent
