CAMP SANTANONI HISTORIC AREA

Proposed Final Unit Management Plan

NYS DEC, REGION 5, DIVISION OF LANDS AND FORESTS

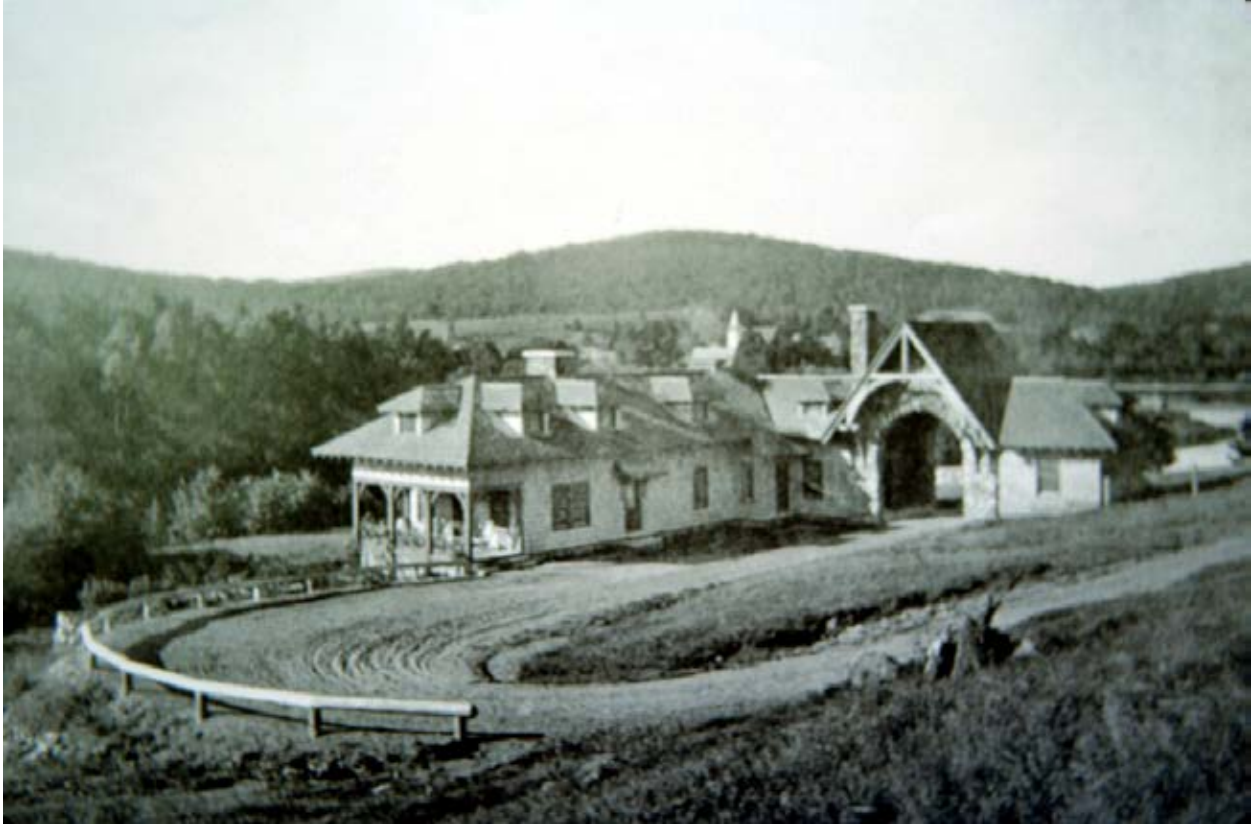
Gate Lodge (1905)

The Gate Lodge is the dominant surviving feature of this complex. It is an L-shaped (approximately 80 ft. x 77 ft.; 2,575 sq. ft.), gable roofed, one-and-one-half-story, field stone and shingle structure with massive stone and wood archway designed by Delano and Aldrich. Entry doors are present on all but the south side of the building. The first floor of this structure contains a foyer, kitchen, utility room, dining room and a living room as well as two lavatories and a porch aligned along a hall along the north wall of the building. A first floor storage room is located on the north side of the arch. The second floor contains six small bedrooms and a full bath aligned along a hall under the north eave. Several dormered windows are present along this hallway. The structure has a full basement with several internal partitions as well as a small crawlspace above the second floor. The original entry road was conveyed under the stone arch by stone walls, now breached, which extended to the entry bridge over Fishing Brook.

The Gate Lodge was modified around 1977-1979, when the structure was used to house members of the Youth Conservation Corps. The two first floor lavatories appear to have been added at this time, the kitchen and second floor bath modernized and showers were added in the basement. The buildings utilities consisting of electricity, water and septic were also upgraded. The roof was also replaced during this period. The structure is considered to be in good condition.

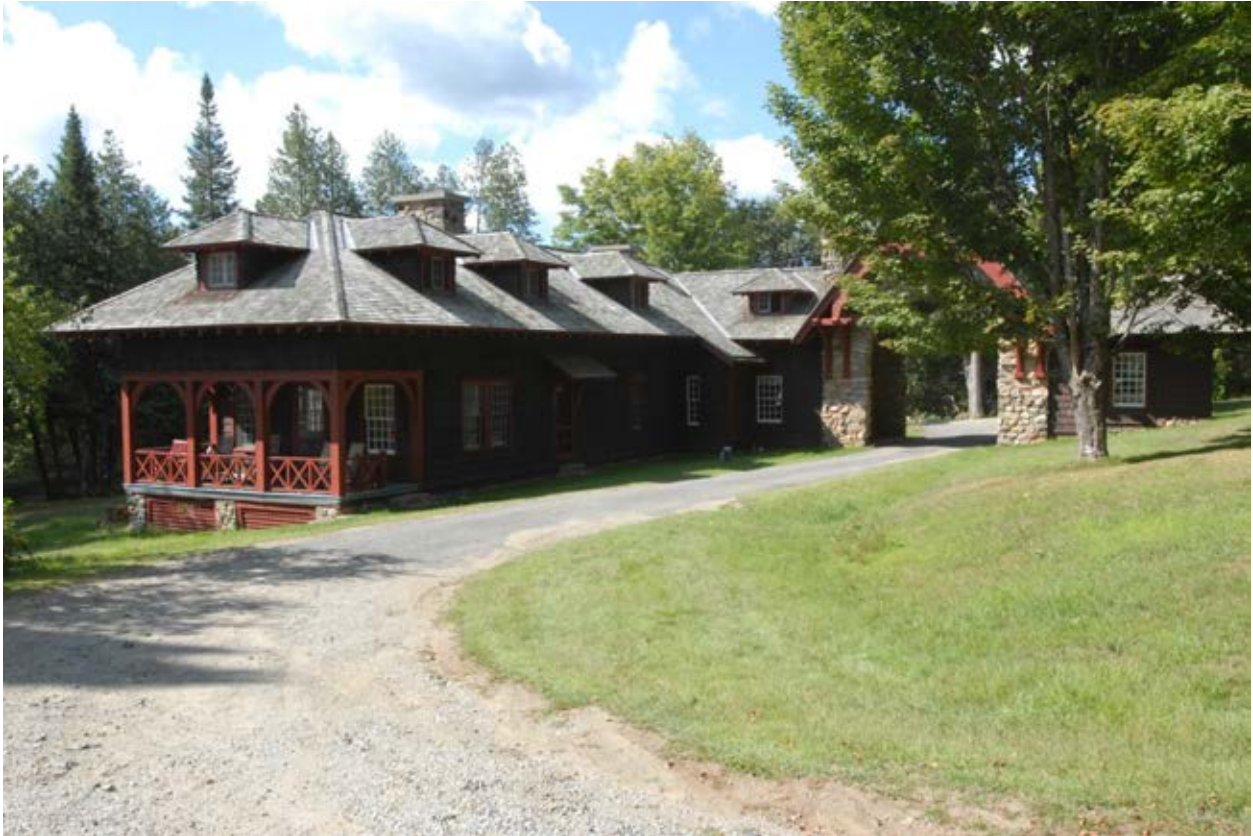
Gate Lodge (2012)

The Gate Lodge was stabilized in 2006-2007. This work included major repairs to the foundation, replacement of the roof, and repair of decorative trim, painting and staining. The exterior porch on the east end of the building has been restored to its original open state.

The Gate Lodge was stabilized in 2006-2007. This work included major repairs to the foundation, replacement of the roof, and repair of decorative trim, painting and staining.

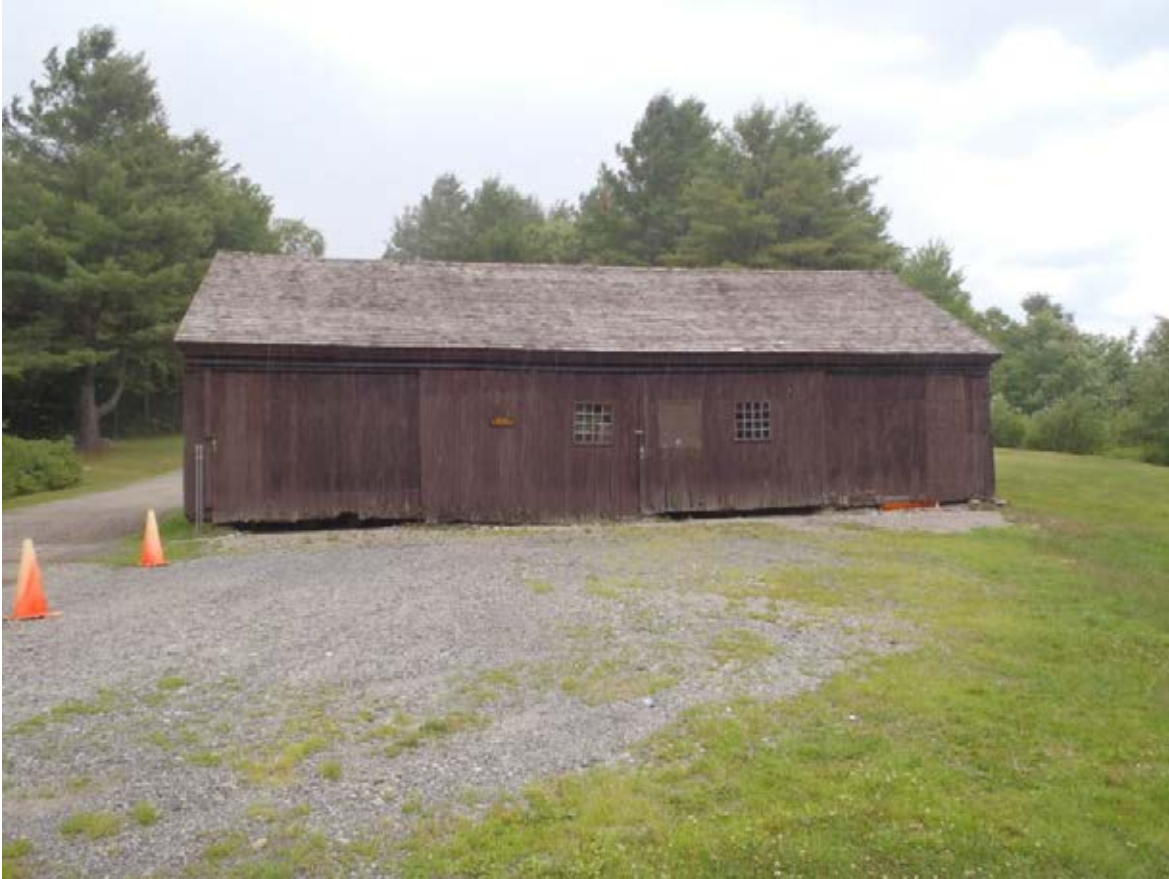
Garage (Construction date and original location unknown)

This building consists of a rectangular (24' x 47'), single-story, pole barn type, gable roofed building with vertical wood siding. This building does not appear to be in its original location, and it is unknown when it was relocated. Its fenestration suggests original construction as part of the complex. The structure is in poor condition.

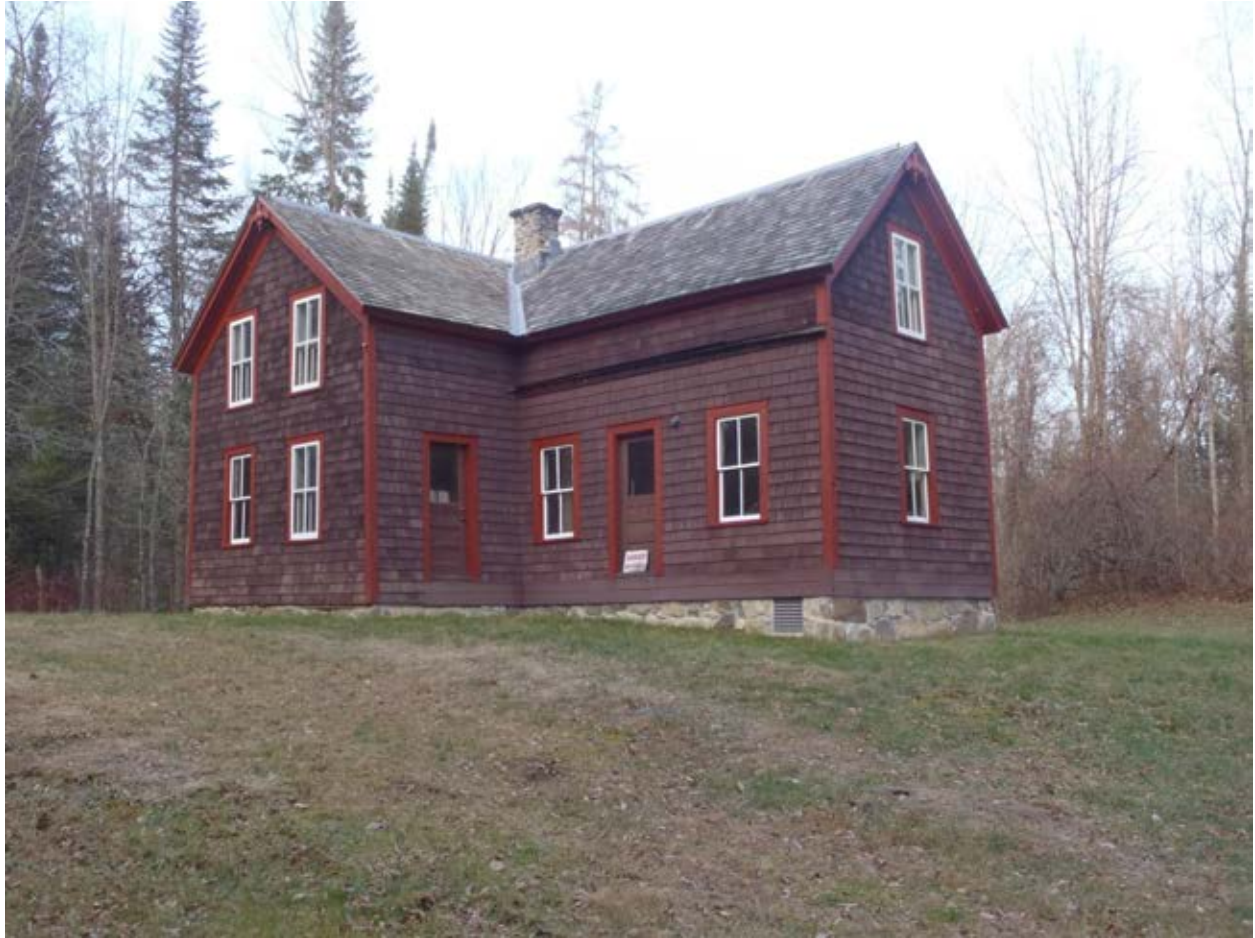
Guides House (West Cottage) (2012)

This is an L-shaped (36' x 43'), two story, wood framed, gable roofed residential structure with shingle siding. Gothic features in the exterior detailing suggest a late 19th century construction date. The structure is in good condition. Also associated with the Guide's House are the ruins of a privy, a small chicken coop and a shed of unknown function. The Guides House was stabilized in 2006 and 2007. This work included foundation, siding and other building envelope repairs, including a new roof, staining and painting.

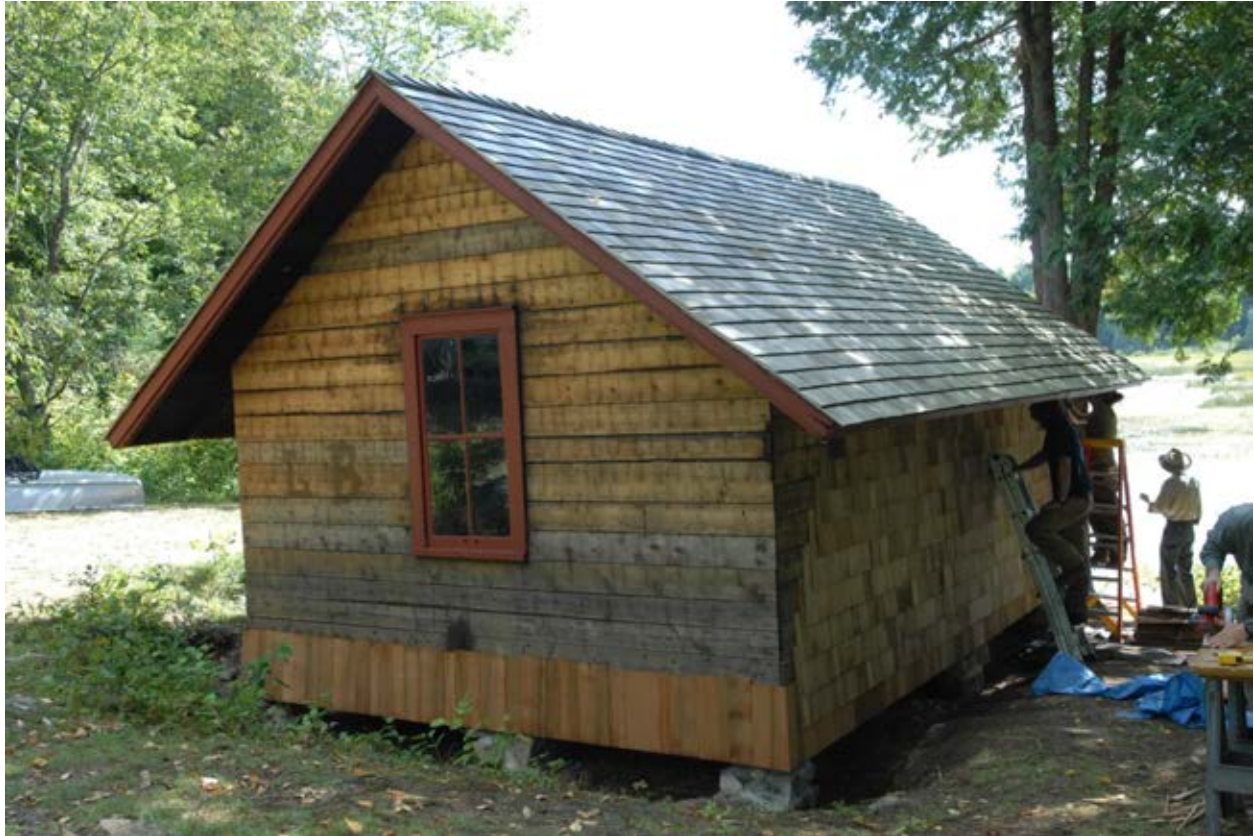
Lake Harris Boat House under restoration (2012)

This is a small storage building on the shore of Lake Harris. It is a single story rectangular (13' x 20') gable roofed, wood framed structure with shingle siding. During the term of the 2000 Camp Santanoni UMP this building was stabilized; footers were rebuilt, siding was repaired and the roof was replaced and the building was re-sided. This structure is in excellent condition.

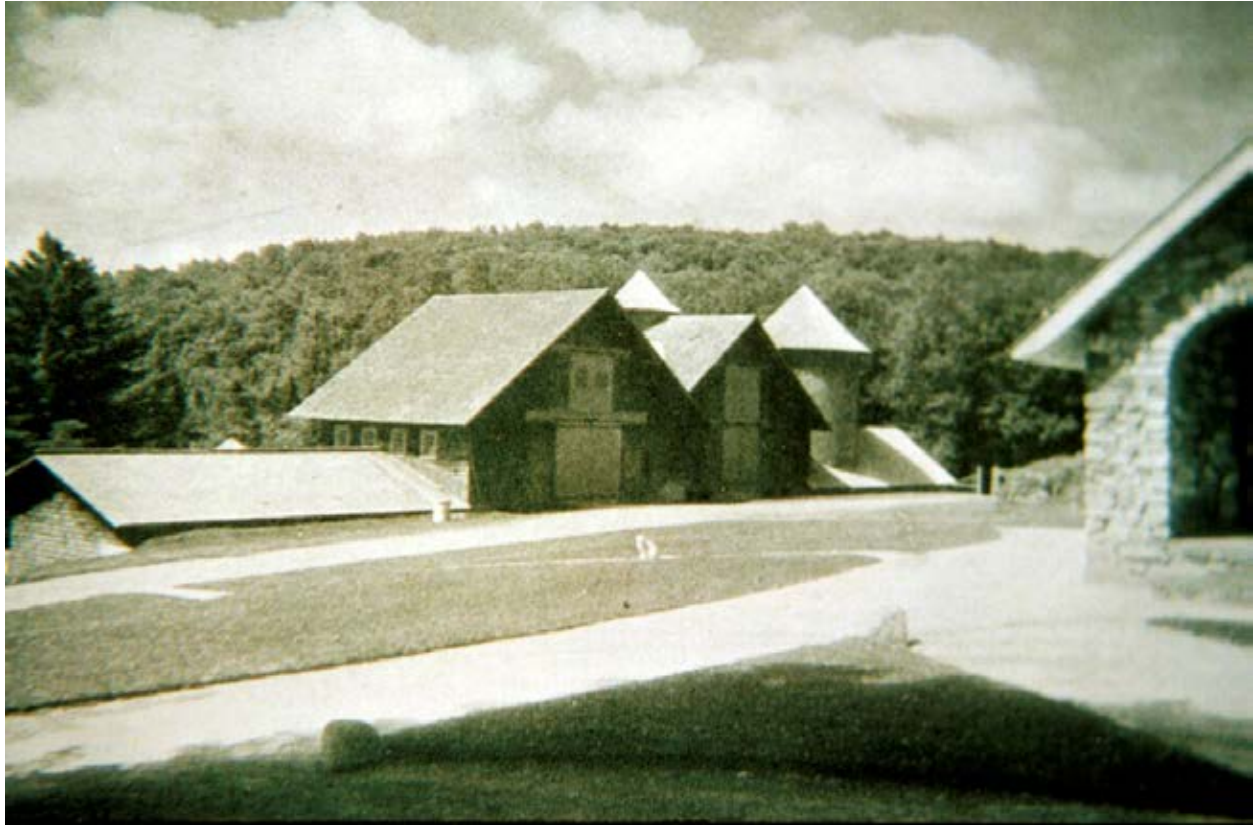
Barn circa 1910

The barn consisted of a three story central core with two wings and additional bays and an incorporated silo. The structure was a combination of post-and-beam and balloon framing. The building was of frame construction for the most part, with some stone foundation components. Haynes (1996) identified six phases of construction for this building. Functionally, the barn was divided into a cow shed, cow barn with manure pit, horse barn and wagon shed. The earliest section of the barn appeared to be the horse barn (1895). The barn was extensively expanded between 1904 and 1908 under the auspices of agricultural designer Edward Burnett, an expert in "scientific farming", who had designed farms for the Vanderbilts and other wealthy landowners. The Barn served as the interpretive focus of the Farm Complex. Efforts to stabilize the Barn were begun

This work was ongoing and was nearly complete when, on July 13, 2004, the Barn was destroyed by fire. The Newcomb Volunteer Fire Department arrived on the scene quickly but a lack of water significantly hampered firefighting efforts. Numerous trips were made to retrieve water at a dry hydrant on Fishing Brook along Route 28N; a trip of nearly a mile. As a result, nearly all of the frame components of the building were consumed, leaving only the foundation and concrete floor. An investigation by the Essex County Office of Emergency Services, the New York State Police, the (then) New York State Department of State Office of Fire Prevention and Control and Department Forest Rangers concluded that the fire was of suspicious origin and most likely arson. The investigation resulted in no arrests.

The loss of the barn structure has caused the foundation of the building to be exposed to water and frost infiltration. The north wall of the Barn also serves as retaining wall for the Newcomb Lake Road which passes immediately adjacent. In order to protect the barn foundation from damage from the elements, a small protective roof was constructed over the north wall and other foundation components were protected with roofing paper.

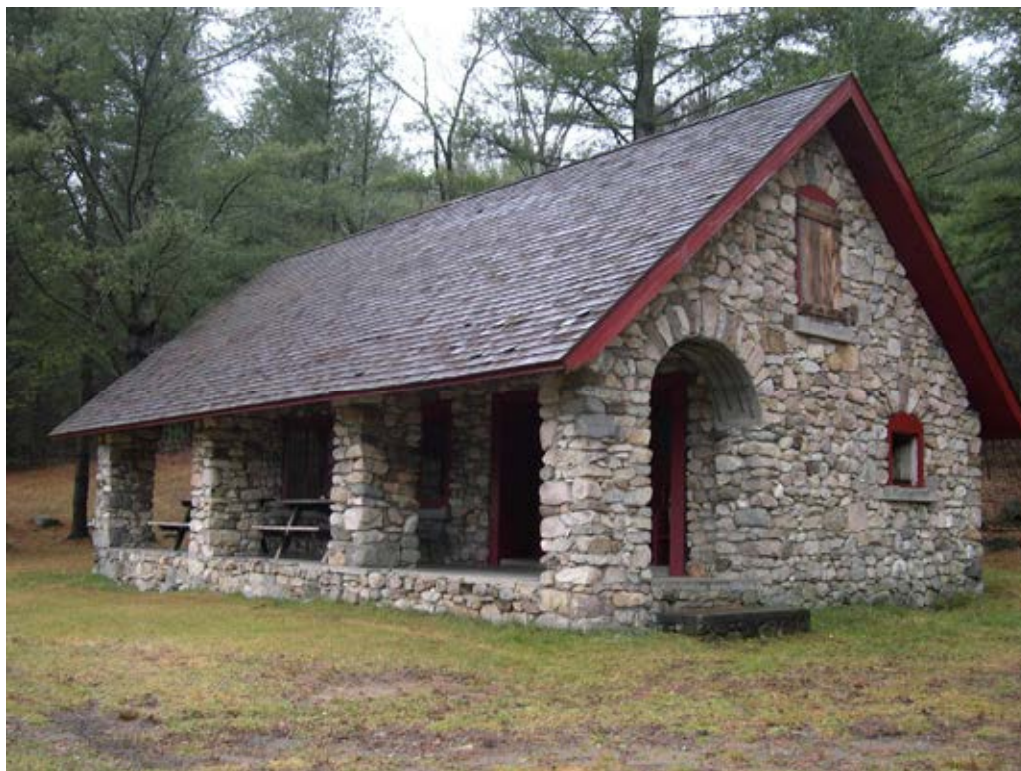
Creamery (2013)

This structure is a single story fieldstone building constructed on a concrete pad. It contains three rooms: a boiler room, wash room and milk processing room. The building has an integral porch along its south face. A cream separator, boiler and other hardware remain intact within the building. During the term of the 2000 UMP, the Creamery received a new roof, repointing and window repairs. This structure is in excellent condition.

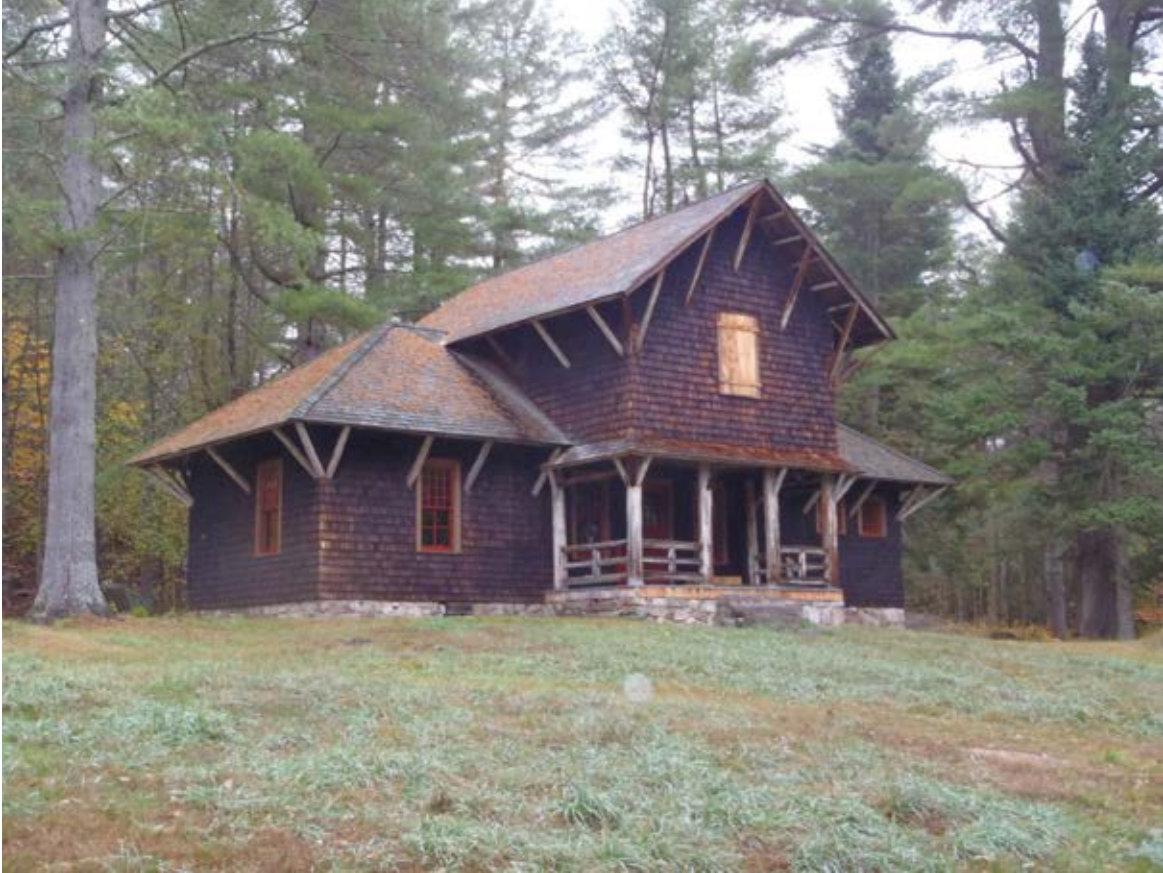
Gardener's (Petoff's) Cottage (2012)

This is a one-and-one-half-story, wood framed, gable roofed, shingled structure with recessed entry porch. Rustic features characteristic of Camp Santanoni residential buildings are present, including peeled log porch framing and under eave braces. The structure appears to have been constructed as part of the expansion and redesign of the farm complex undertaken by Edward Burnett. It was expanded at least once in its history. The cottage contains a parlor, kitchen, laundry room, pantry, three bedrooms, a bath and an attached wood shed. The exterior of the structure retains its original design and finishes. The interior of the structure was modernized, probably during the Melvin period, although original woodwork and moldings remain. Structurally, the building is in good condition.

The Environmental Protection Fund grant received in 1996 provide for the maintenance of the Gardener's Cottage which is a highly significant component of the Farm Complex. Work completed includes stabilization and restoration of the missing and damaged, structural members and exterior walls, interior floors and walls of the building, replacement and repairs of missing or broken windows, and making the building weather-tight. This work has been completed.

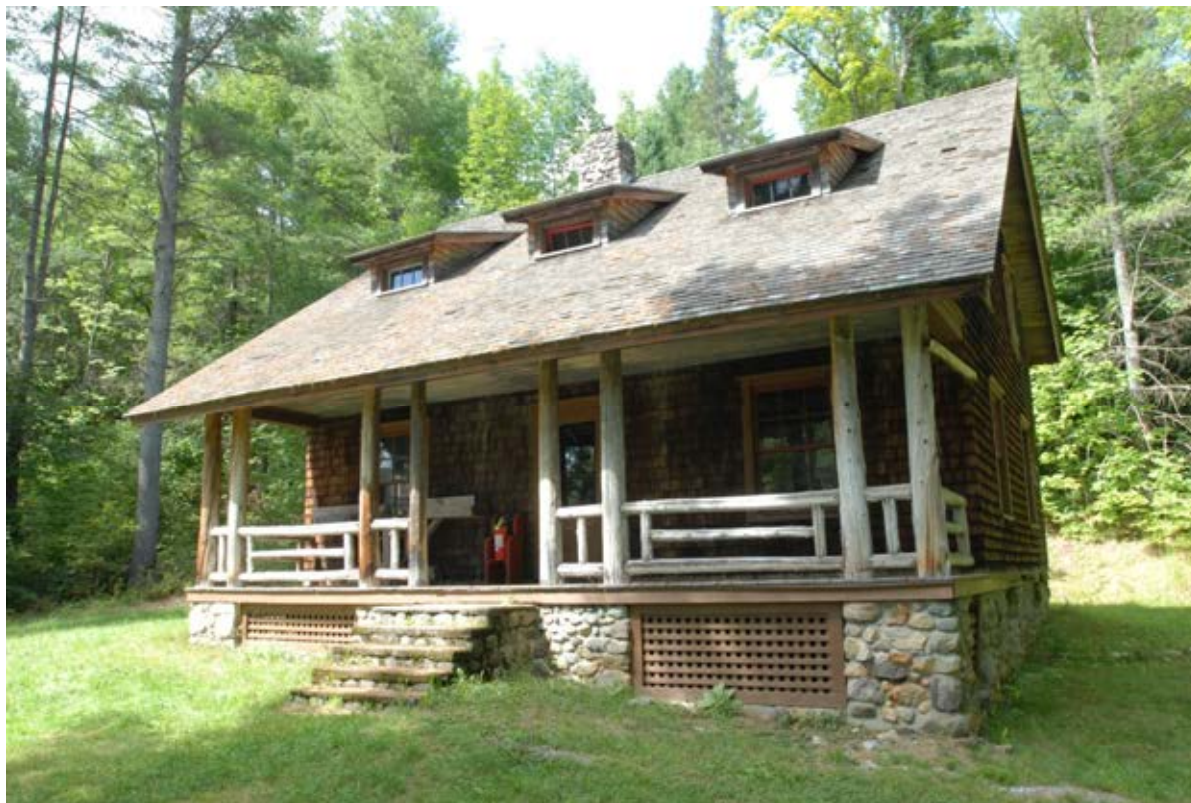
Herdsman's (Ross') Cottage (2012)

This is a one-and-one-half-story, wood framed, gable roofed, shingled structure with recessed entry porch and cobblestone chimney. This structure appears to predate the Pruyn occupation of the property and may represent the residence of a mid-nineteenth century farmstead believed to have existed on the property by ca 1850. The Herdsman's cottage also exhibits rustic features such as peeled log porch frame and under eave braces. The building appears to have been remodeled several times during the Pruyn occupation with stylistic details comports with newer buildings added to the farm complex. The exterior of the structure retains its original design and finishes. This cottage contains a parlor, dining room, kitchen, serving pantry, a bedroom and an attached wood shed on the first floor. The second floor contains a full bath and four bedrooms. The interior of the structure was modernized, probably during the Melvin period.

The Environmental Protection Fund grant received in 1996 provide for the maintenance of the Herdsman's Cottage which was in poor condition but is a highly significant component of the Farm Complex. Work completed includes stabilization and restoration of the missing and damaged, structural members and exterior walls, interior floors and walls of the building, replacement and repairs of missing or broken windows, and making the building weather-tight. This work has been completed.

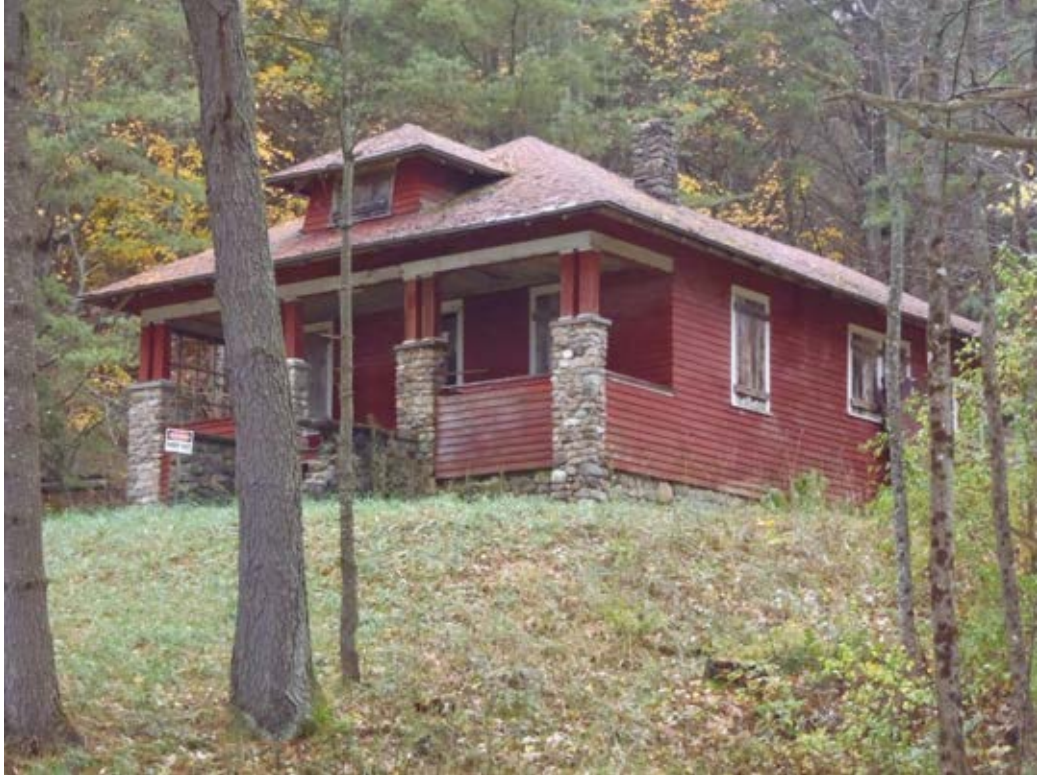
Caretaker's or New Farm Manager's (Tummins's) Cottage (2012)

Also known as the Farm Manager's Cottage, this is one-and-one-half-story, wood framed, hip-roofed bungalow style, clapboard sided structure with recessed entry porch. The building is distinctive compared to other buildings on the property, having as its core a Harris catalog house. The structure was occupied by employees of the Pruyn's and the Melvin's from 1919 through 1974. The building retains its original exterior features and trim, but the interior has been modernized. Structurally the building is in very poor condition. A project was undertaken in 2013 to replace the roof and stabilize this structure and remains under way.

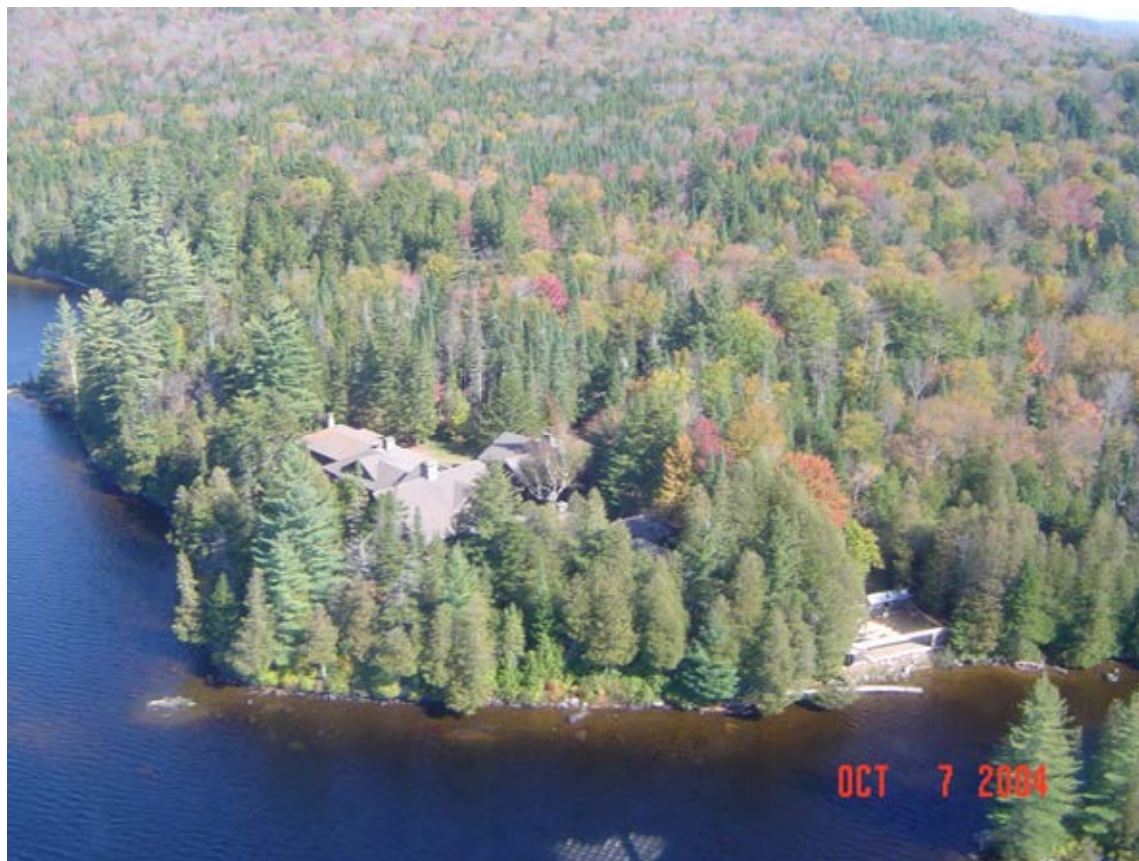
Main Lodge (2004)

The lodge is composed of five log pavilions under an immense roof with wide overhangs and hip-roofed projections including a gable roofed porte-cochere. It has been characterized as a log villa. The center pavilion consists of a great one-and-one-half-story living hall with massive stone fireplace. It is flanked on opposite (east & west) sides by four sleeping cabins/cottages. The structure covers an area of 15,000 square feet. During the term of the original UMP repairs were made to structural components of the porches and much of the decking was replaced.

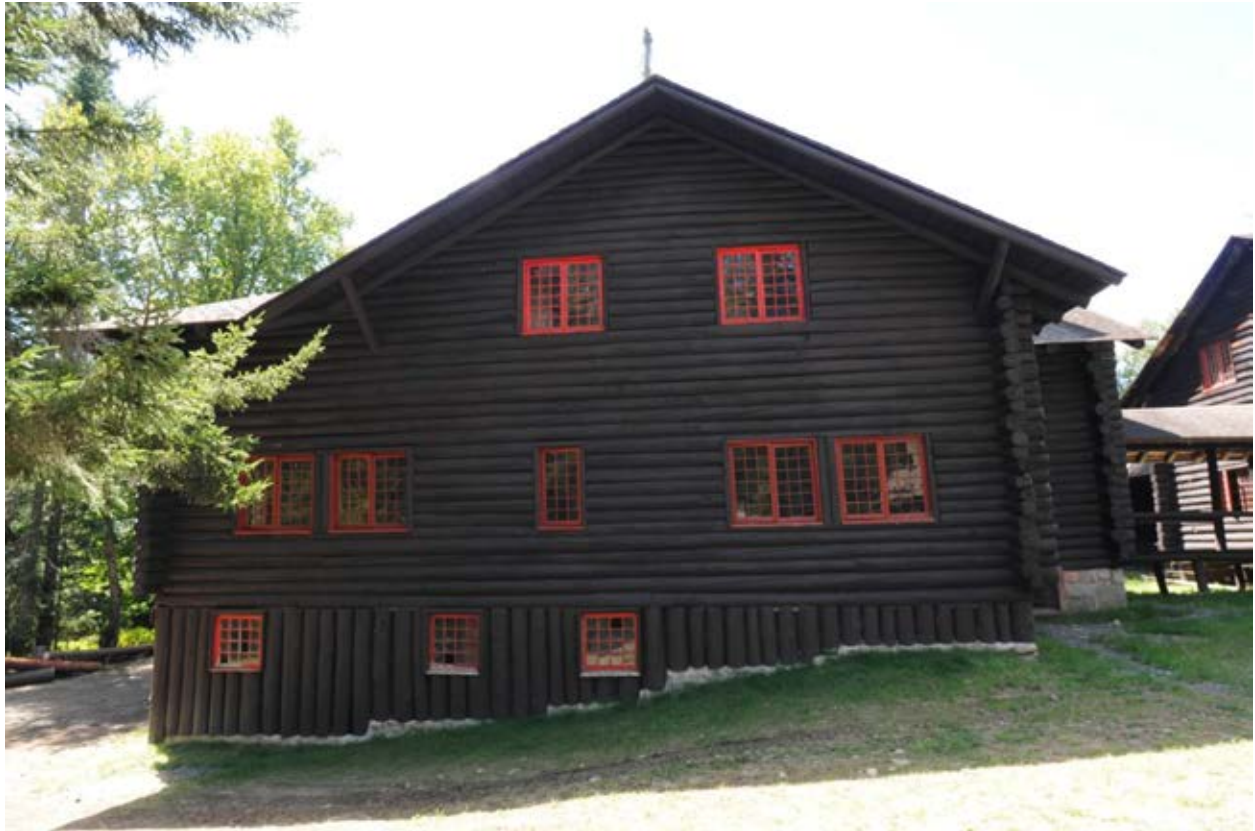
Main Lodge Kitchen Wing (2012)

This is a detached, three story log structure (50' x 50') on log piers connected to the main lodge via a covered walkway. It includes a massive ashlar stone chimney and built-in ice chests on a recessed porch. The Kitchen Wing has been stabilized and has had its foundation reinforced. Significant work remains in stabilizing and repairing interior components.

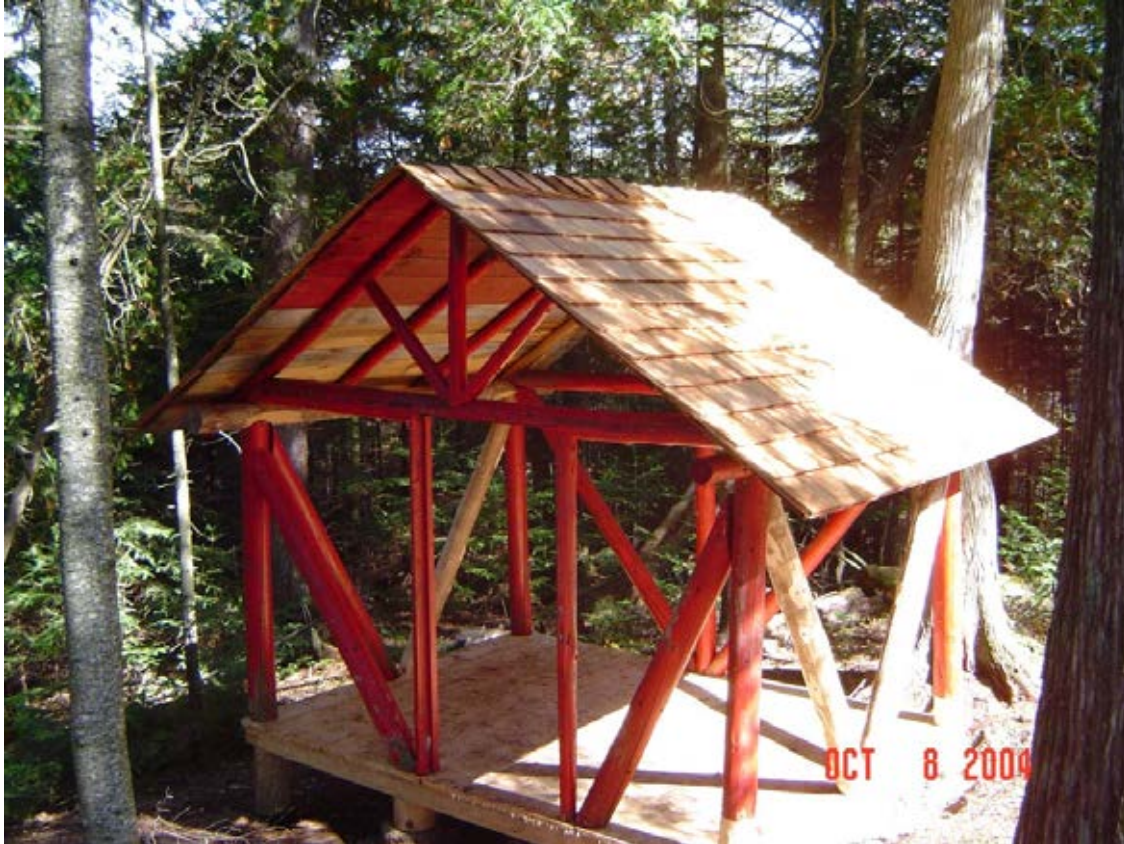
Gazebo (2004)

This is a small (7' x 10'), log braced and log supported single-story screened pavilion. This structure has been stabilized and re-roofed.

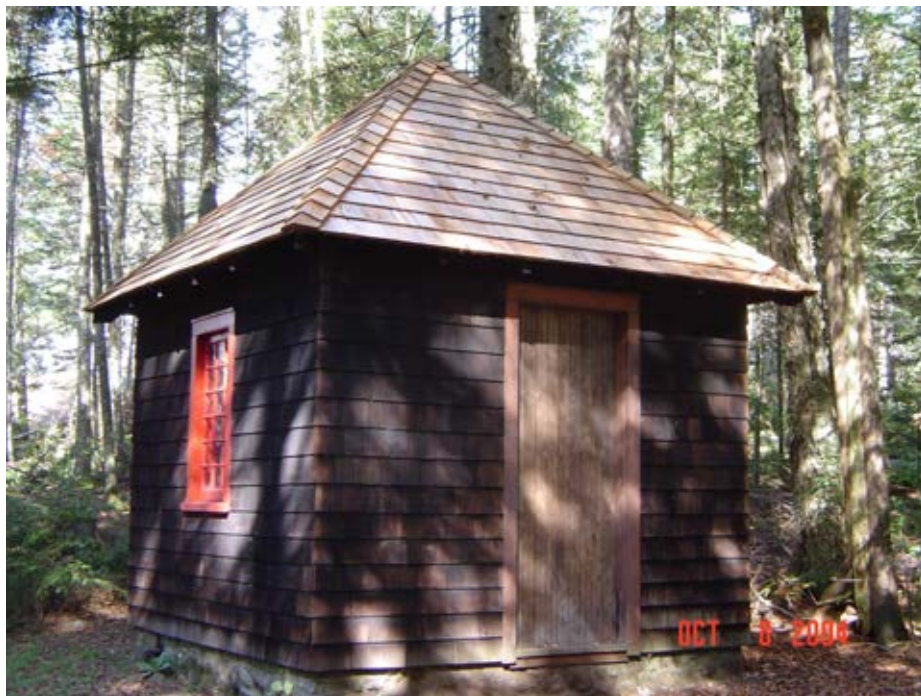
Power House (2004)

This is a very small, square (8' x 6'), single-story, shingled, wood framed building. The generator in the power house operated an “on demand” electrical system which was wired to the Main Lodge. This building has been stabilized with a new roof and window restoration.

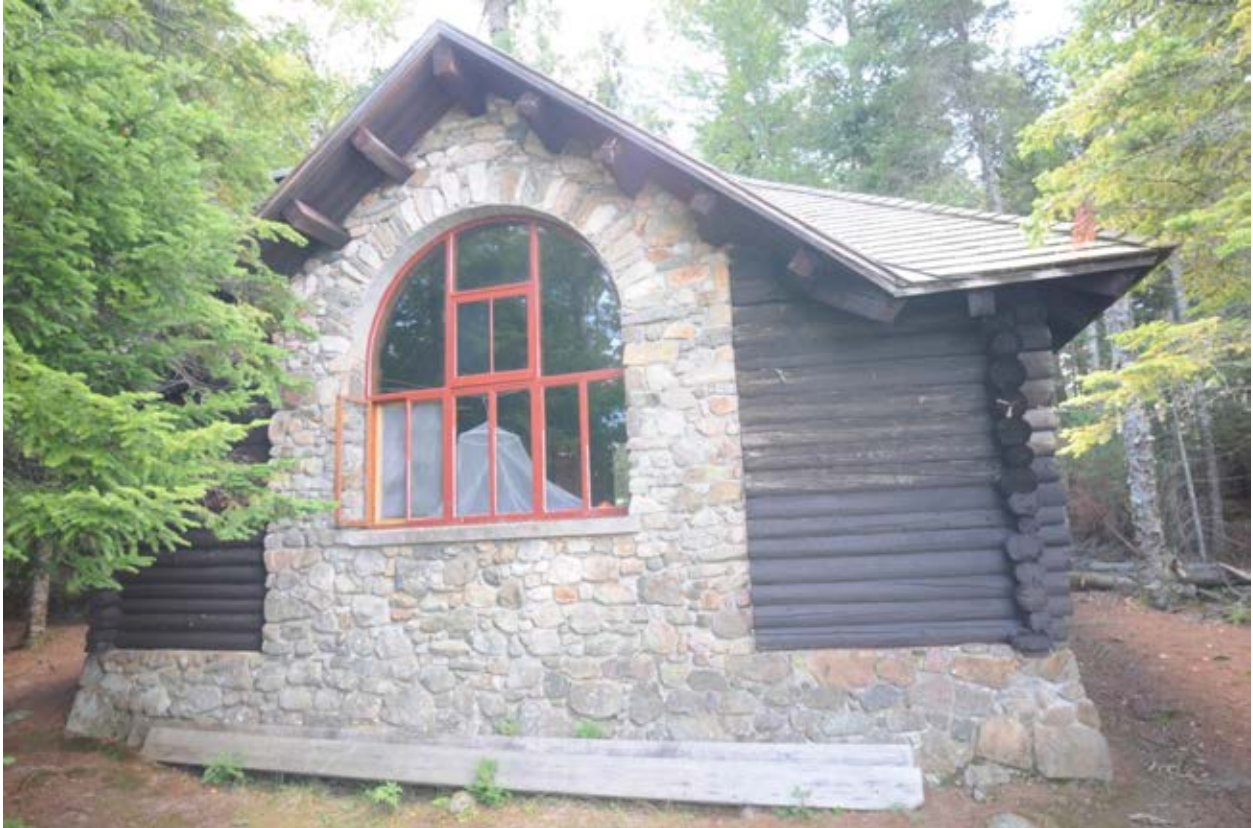
Artist's Studio (2012)

This is a small, single-story, rectangular (19' x 28') log structure with a hipped roof. Sited along the shoreline of Newcomb Lake, it features a stone-arched lakeside window as well as a stone chimney and fireplace.

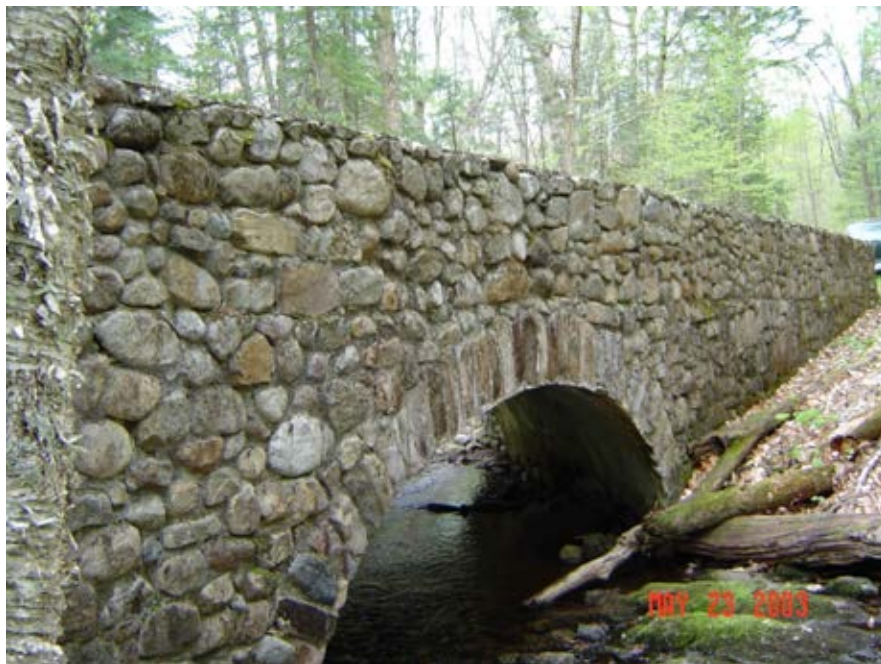
Outer Twin (2003)

This is similar in size and condition to middle culvert, although spandrel walls have not been displaced as severely. This structure was rebuilt in 2013-2014.
