# **Sharp Bridge Public Campground**

## **Unit Management Plan**

Town of North Hudson, Essex County, New York

**January 2023**

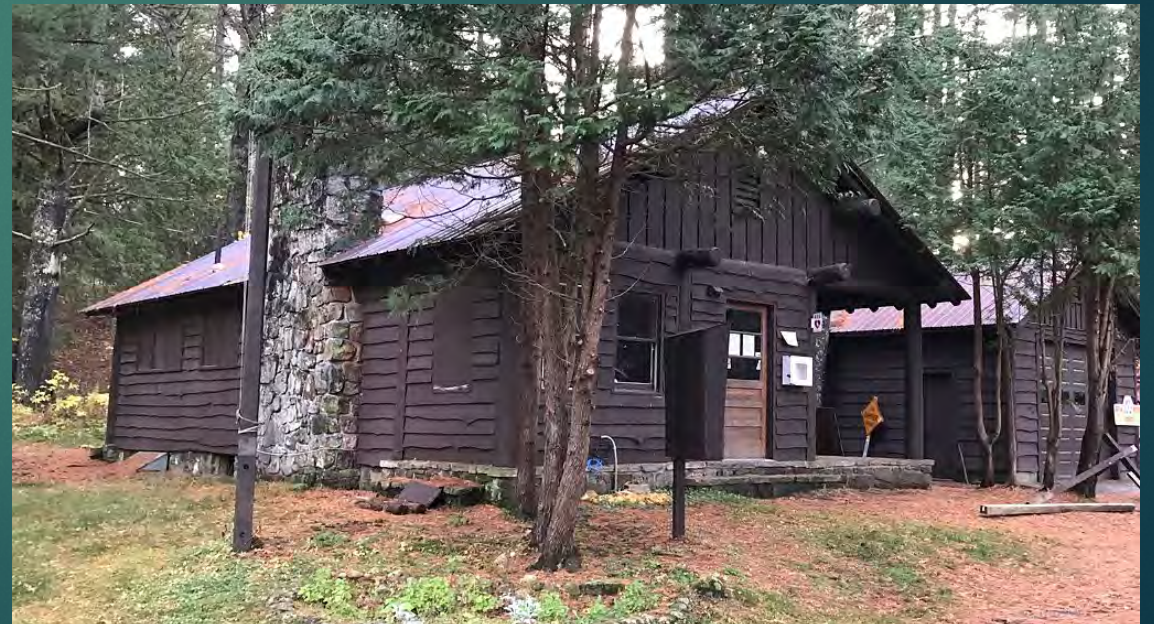
Caretaker Cabin and Office.

### **1. Replace Caretaker Cabin.**

Sharp Bridge campground requires a staff of one, who is on premises 24 hours a day. There is currently one building available to house employees who live beyond a reasonable commute. The existing caretaker cabin was built in 1948 and is in fair condition. The building should be replaced to accommodate staff and their family, if required. This management action proposes to replace the building with a four-bedroom home in the same footprint and will meet all codes. This will also be available for larger facilities nearby to house staff. Siting will prioritize the use of existing disturbed areas to limit clearing of existing vegetation and minimizing topographic alterations.

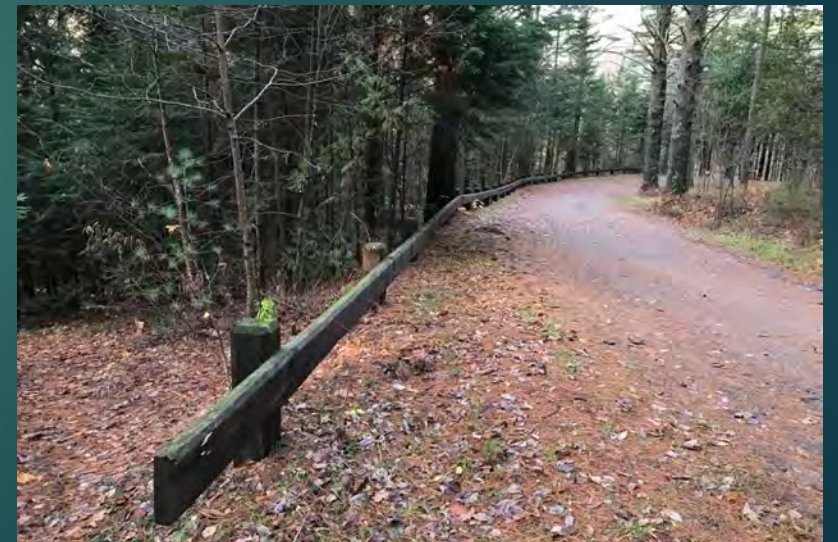
Paved Road with Guardrail into Camping Area.

The .90 mile of interior campground road is in poor condition with crumbling shoulders and potholes. The entire .90 mile of roadway needs to be repaved, while the additional .28 mile of campsite driveway and access roads should be maintained as gravel. Where possible, roads rehabilitation design should consider access for emergency response and maintenance vehicles. Based on current and anticipated visitor use, most of the campground would require a typical one-way road. The entrance road will be a typical main road, paved, and measure 916 feet. The road beyond the trailer dump station continuing to the shower building and the junction near campsite 20 would require a two-way road to safely accommodate campers. In addition to the main road, a total of 1,236 feet of paved two-way road

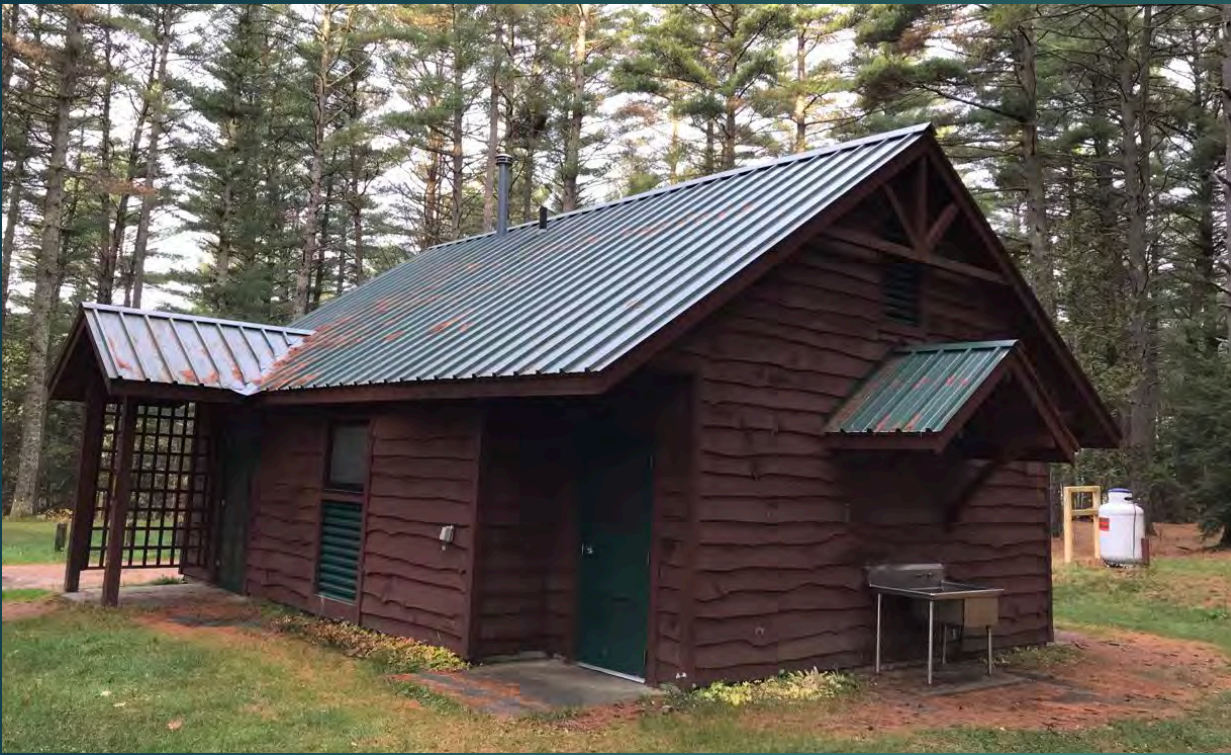
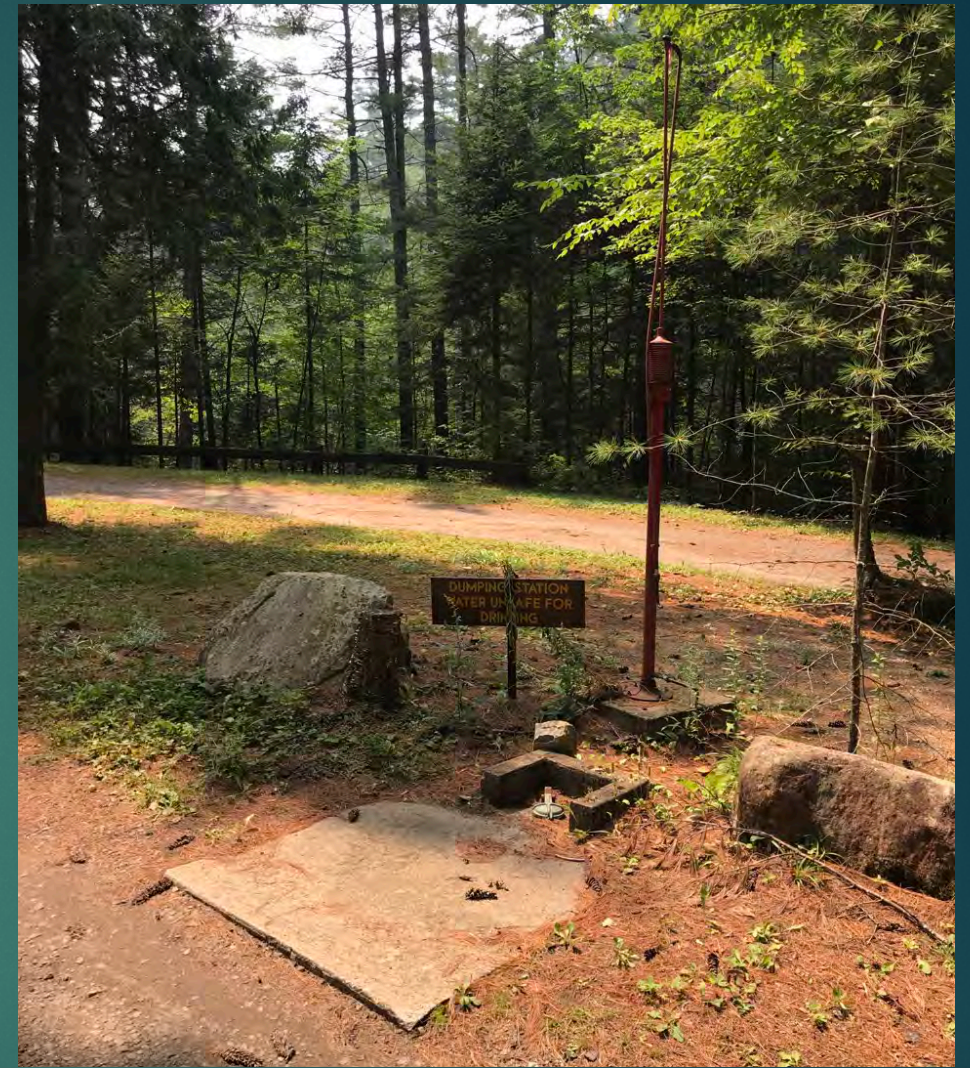
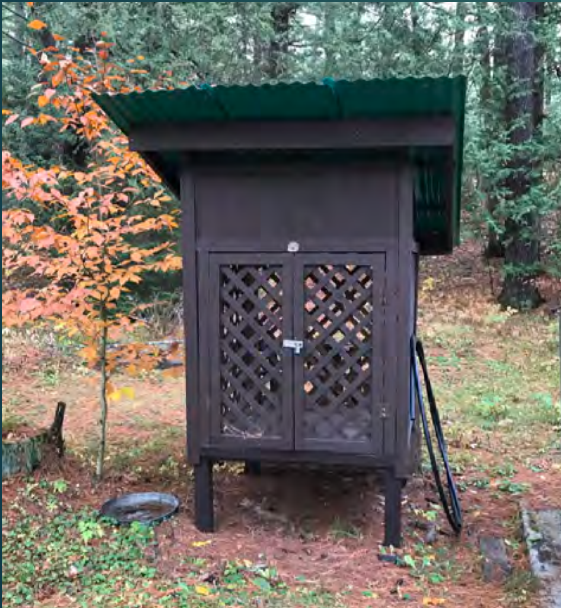
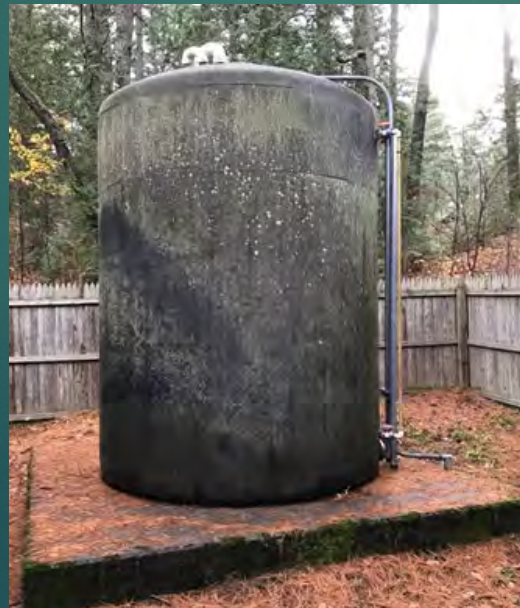
Photos (clockwise from top left): Shower Building, Trailer Dumping Station, Water Reservoir, Firewood Storage.

### **3. Replace Trailer Dumping Station.**

This management action proposes to replace the existing trailer dumping station to better accommodate modern camping trailers while meeting current standards for accessibility and design standards. A single-lane trailer dumping station with an improved septic system will be located in the existing site or an alternative site where design limitations allow. Siting will prioritize limiting vegetative clearing or topographic alteration. The final location for the trailer dump station will meet Master Plan guidance for setbacks in Intensive Use Areas. Additionally, setback requirements outlined in Wild, Scenic, and Recreation River permitting guidelines will be adhered to during the design process.

The water system at Sharp Bridge is old and needs rehabilitation to meet current DOH regulations. The buried waterlines, tanks, and well should be replaced. Additional water spigots should be installed as necessary to meet health codes and accessibility standards. Tree and shrub replanting will be required to replace any vegetative loss due to clearing. This management action proposes to rehabilitate the existing water system to meet current design standards and Department of Health codes.
