New York State
Adirondack
Park Agency

NOTICE OF INCOMPLETE PERMIT APPLICATION
APA Project No.: 2023-0045

Type of Project: application of aquatic herbicide involving wetlands

Location of Project: Town of Lake Luzerne, Warren County
Land Use Area: Underwater Lands

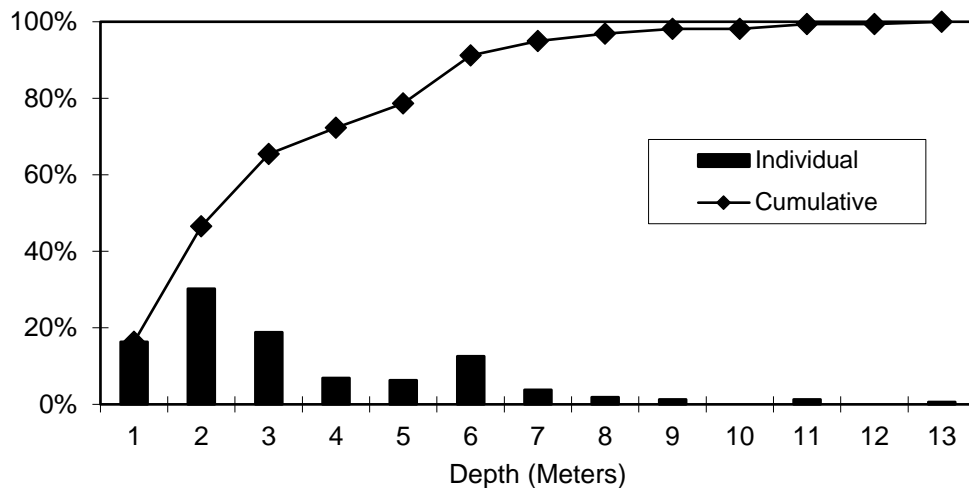
Figure 3. Distribution of Lake Luzerne sampling points in 1 meter depth classes.

The littoral zone is the area of the lake bottom supporting rooted aquatic plant growth and is generally defined by the maximum depth to which sufficient light penetrates to allow for plant growth. In Lake Luzerne, depth distribution of native species remained similar to past surveys with aquatic plant growth observed to a maximum depth of 5.5 meters (16 feet). Macroalgae or charophytes form a carpet at the outer margin of plant growth, in depths from 5 to 7 meters (16 to 22 feet). While Eurasian watermilfoil occurred throughout Lake Luzerne, dense growth typically was found in depths from 3 to 10 feet. Depth distribution of sampling points (Figure 3) was primarily within the littoral zone (less than 6 meters), however most depths in Lake Luzerne were sampled.

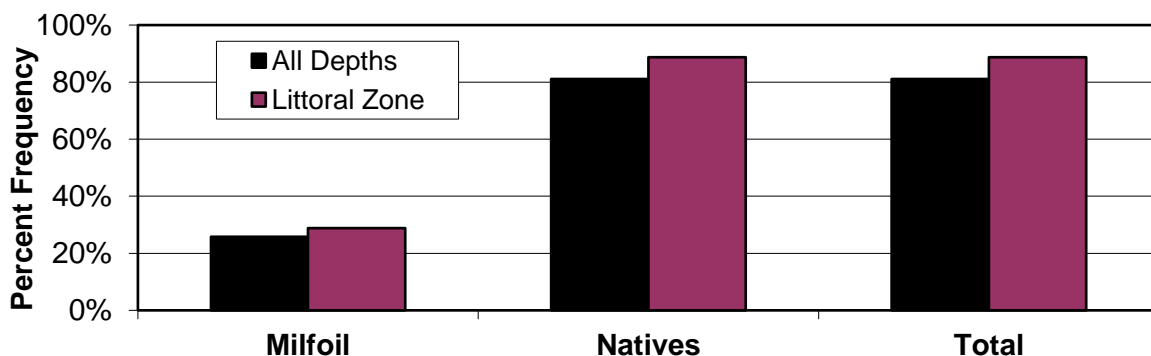
Figure 4. Lake Luzerne frequency of occurrence summaries lakewide in 2021.

Eighty-one percent of whole lake sampling points were vegetated by at least one plant species in 2021 (Figure 4) comparable to the 85%, 84% and 89% reported for 2019, 2010 and 2009,

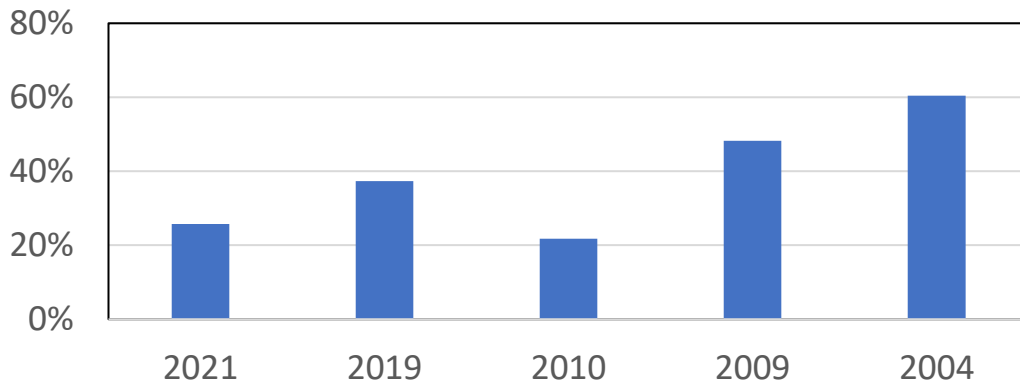
Figure 5. Lake Luzerne Eurasian watermilfoil frequency of occurrence.

respectively. In depths of 6 m or less, representing the littoral zone, 89% of survey points contained native species in 2021, while 98% were reported in 2019 and 95% of survey points were reported in both 2009 and 2010 surveys. Eurasian watermilfoil was present in 26% of survey points in 2021, 32% in 2019 and 24% of survey points in 2010, a slight change over 9 years. A general decline in Eurasian watermilfoil abundance was observed between 2004 and 2010 (Figure 5), most likely a result of aquatic plant management efforts.

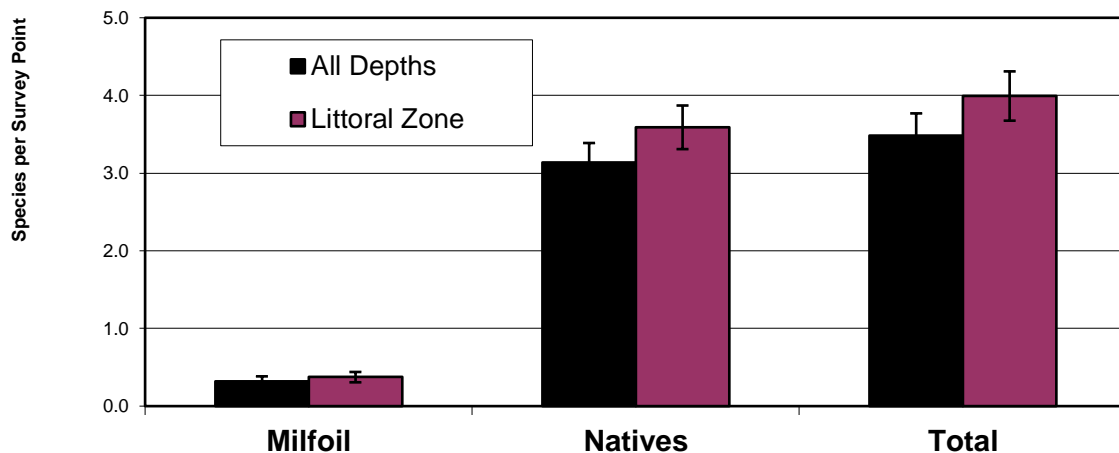
Lake Luzerne Aquatic Vegetation Species Richness Levels

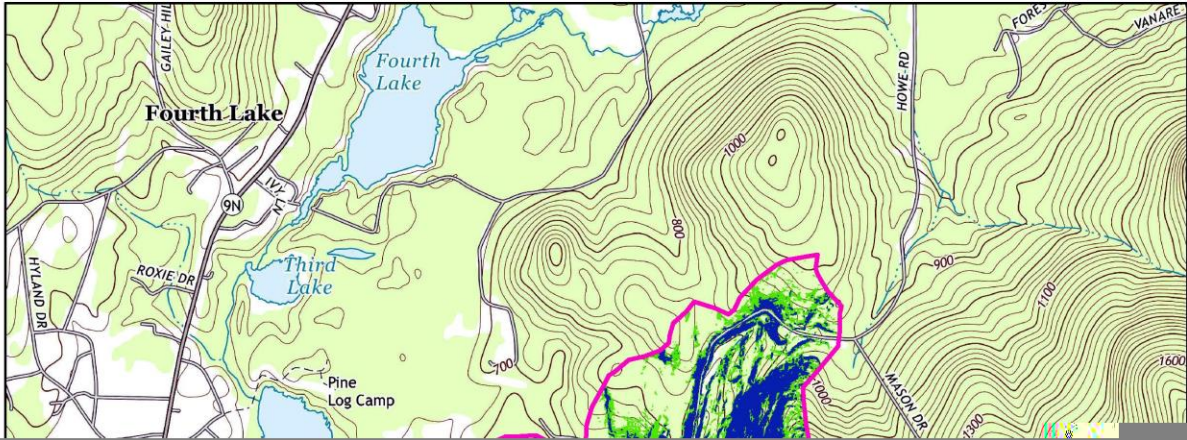
Figure 5 **Steep Slopes Map**

The general character of the lake sub-watershed is that it has variable terrain that can be either gently rolling but in places steep. The highest elevation in the lake sub-watershed is 1,662 feet, southwest of Bucktail Mountain on a separate peak.

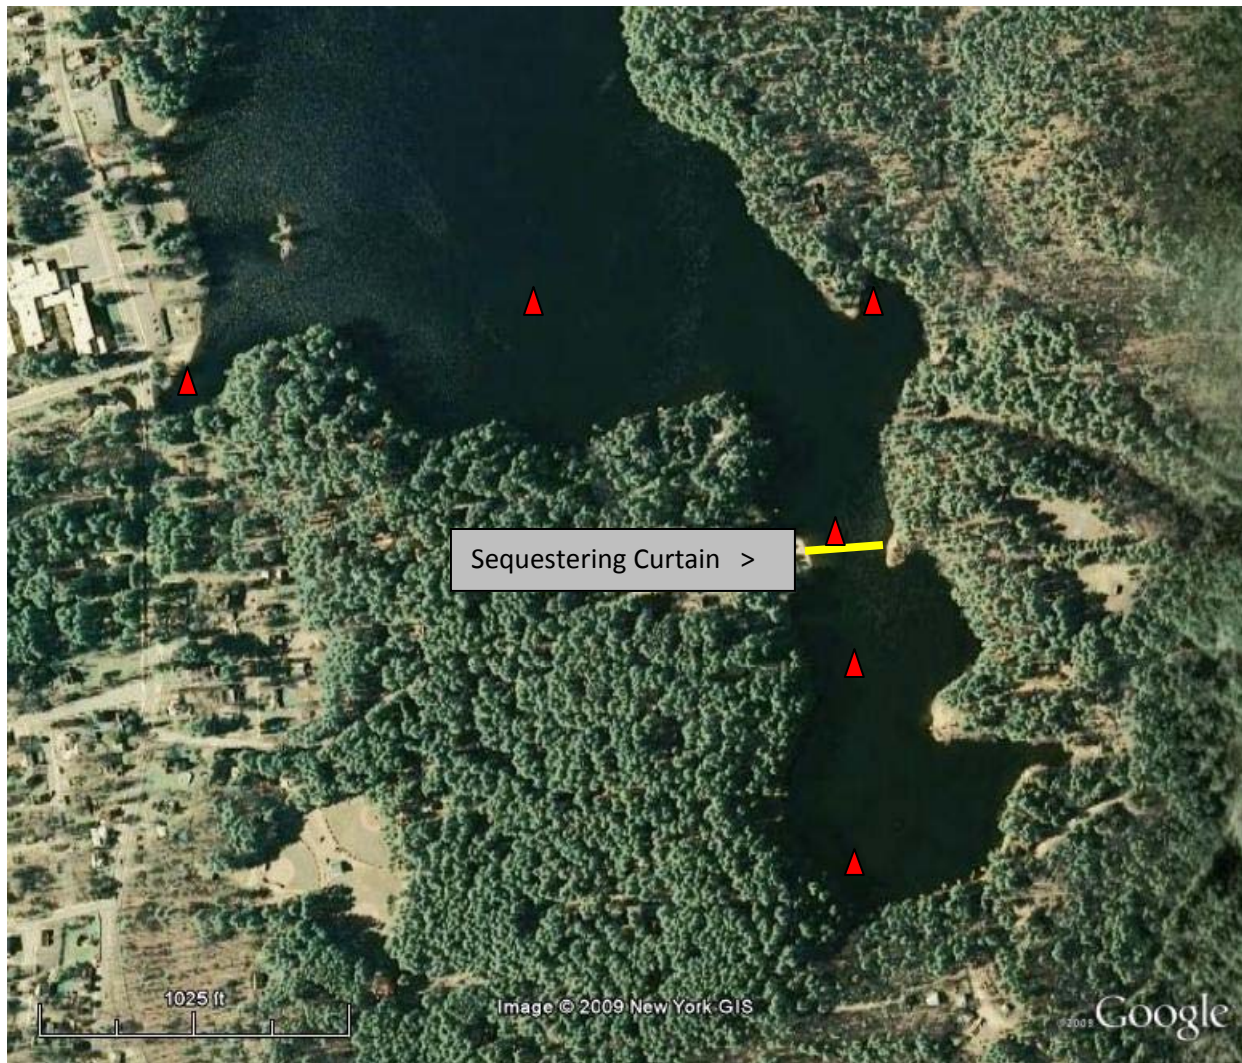
▲ FasTEST sampling locations for residual triclopyr concentrations
