2023 West Caroga Lake AIS Survey

Aquatic Invasive Species Surveys
Survey Team Report

2023 West Caroga Lake Aquatic Invasive Species Survey

Ezra Schwartzberg, Ph.D. and Justin Wolford
Adirondack Research
October 2023

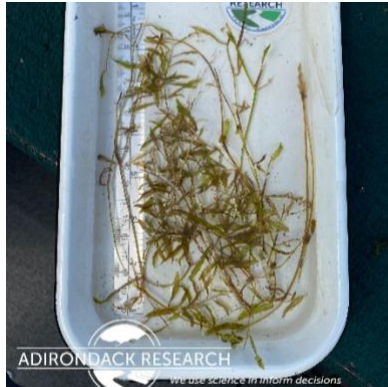
Caption: Variable-leaf pondweed (*Potamogeton gramineus*)

Variable-leaf pondweed (*Potamogeton gramineus*): This plant was found at a total of 4 out of 43 stations resulting in 9.30% of occurrences. It was most commonly found growing at less than 5% levels, (n=2, 50.00%) followed by 51% - 75% levels, (n=1, 25.00%) followed by 5% - 25% levels, (n=1, 25.00%).

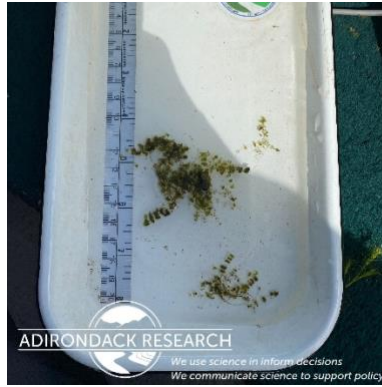
Caption: *Nitella* sp

Nitella sp.: This plant was found at a total of 7 out of 43 stations resulting in 16.28% of occurrences. It was most commonly found growing at less than 5% levels, (n=4, 57.14%) followed by 5% - 25% levels, (n=3, 42.86%).

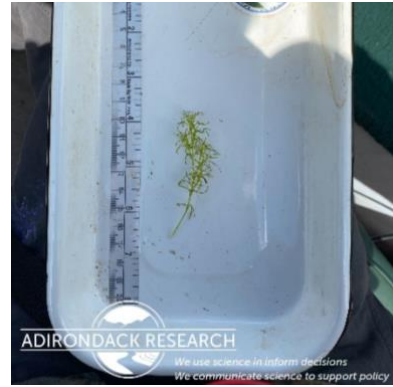
Caption: Slender naiad (*Najas flexilis*)

Slender naiad (*Najas flexilis*): This plant was found at a total of 3 out of 43 stations resulting in 6.98% of occurrences. It was most commonly found growing at less than 5% levels, (n=3, 100.00%).

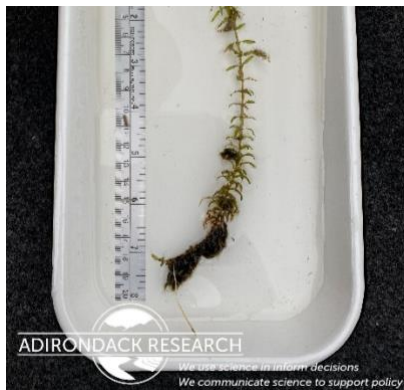
Caption: Common elodea (*Elodea canadensis*)

Common elodea (*Elodea canadensis*): This plant was found at a total of 1 out of 43 stations resulting in 2.33% of occurrences. It was most commonly found growing at less than 5% levels, (n=1, 100.00%).

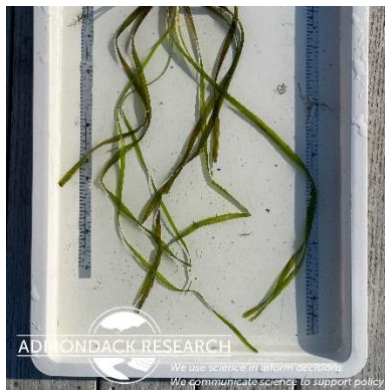
Caption: Eel grass (*Vallisneria americana*)

Eel grass (*Vallisneria americana*): This plant was found at a total of 10 out of 43 stations resulting in 23.26% of occurrences. It was most commonly found growing at less than 5% levels, (n=10, 100.00%).

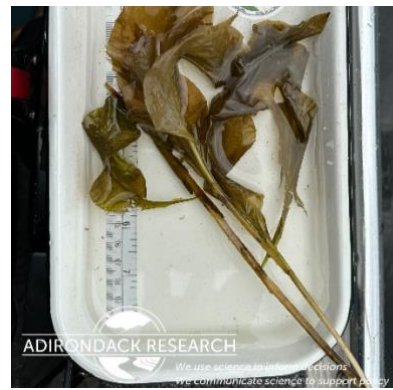
Caption: Large-leaf pondweed (*Potamogeton amplifolius*)

Large-leaf pondweed (*Potamogeton amplifolius*): This plant was found at a total of 14 out of 43 stations resulting in 32.56% of occurrences. It was most commonly found growing at less than 5% levels, (n=7, 50.00%) followed by 5% - 25% levels, (n=7, 50.00%).

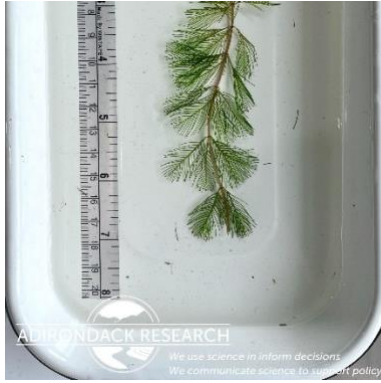
Caption: Eurasian watermilfoil
(*Myriophyllum spicatum*)

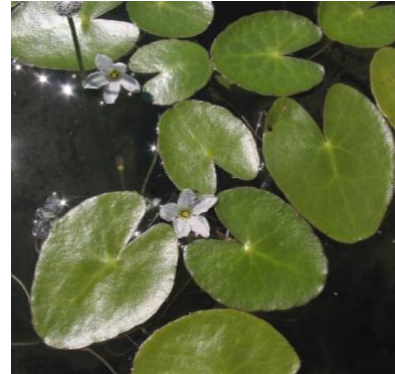
Caption: Little floating heart
(*Nymphoides cordata*)

Little floating heart (*Nymphoides cordata*): This plant was found at a total of 5 out of 43 stations resulting in 11.63% of occurrences. It was most commonly found growing at less than 5% levels, (n=4, 80.00%) followed by 5% - 25% levels, (n=1, 20.00%).

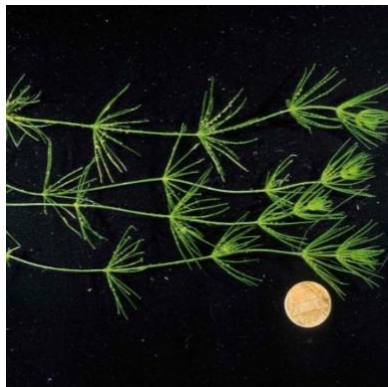
Caption: Muskgrass (*Chara spp.*)

Muskgrass (*Chara sp.*): This plant was found at a total of 1 out of 43 stations resulting in 2.33% of occurrences. It was most commonly found growing at 5% - 25% levels, (n=1, 100.00%).

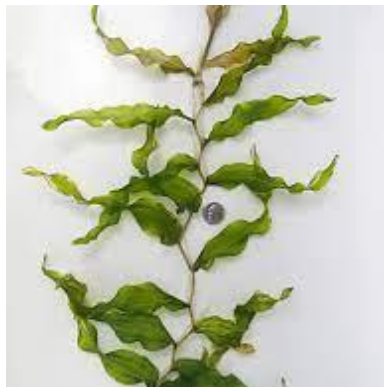
Caption: White stemmed
pondweed (*Potamogeton
praelongus*)

White stemmed pondweed (*Potamogeton praelongus*): This plant was found at a total of 8 out of 43 stations resulting in 18.60% of occurrences. It was most commonly found growing at 5% - 25% levels, (n=6, 75.00%) followed by less than 5% levels, (n=2, 25.00%).

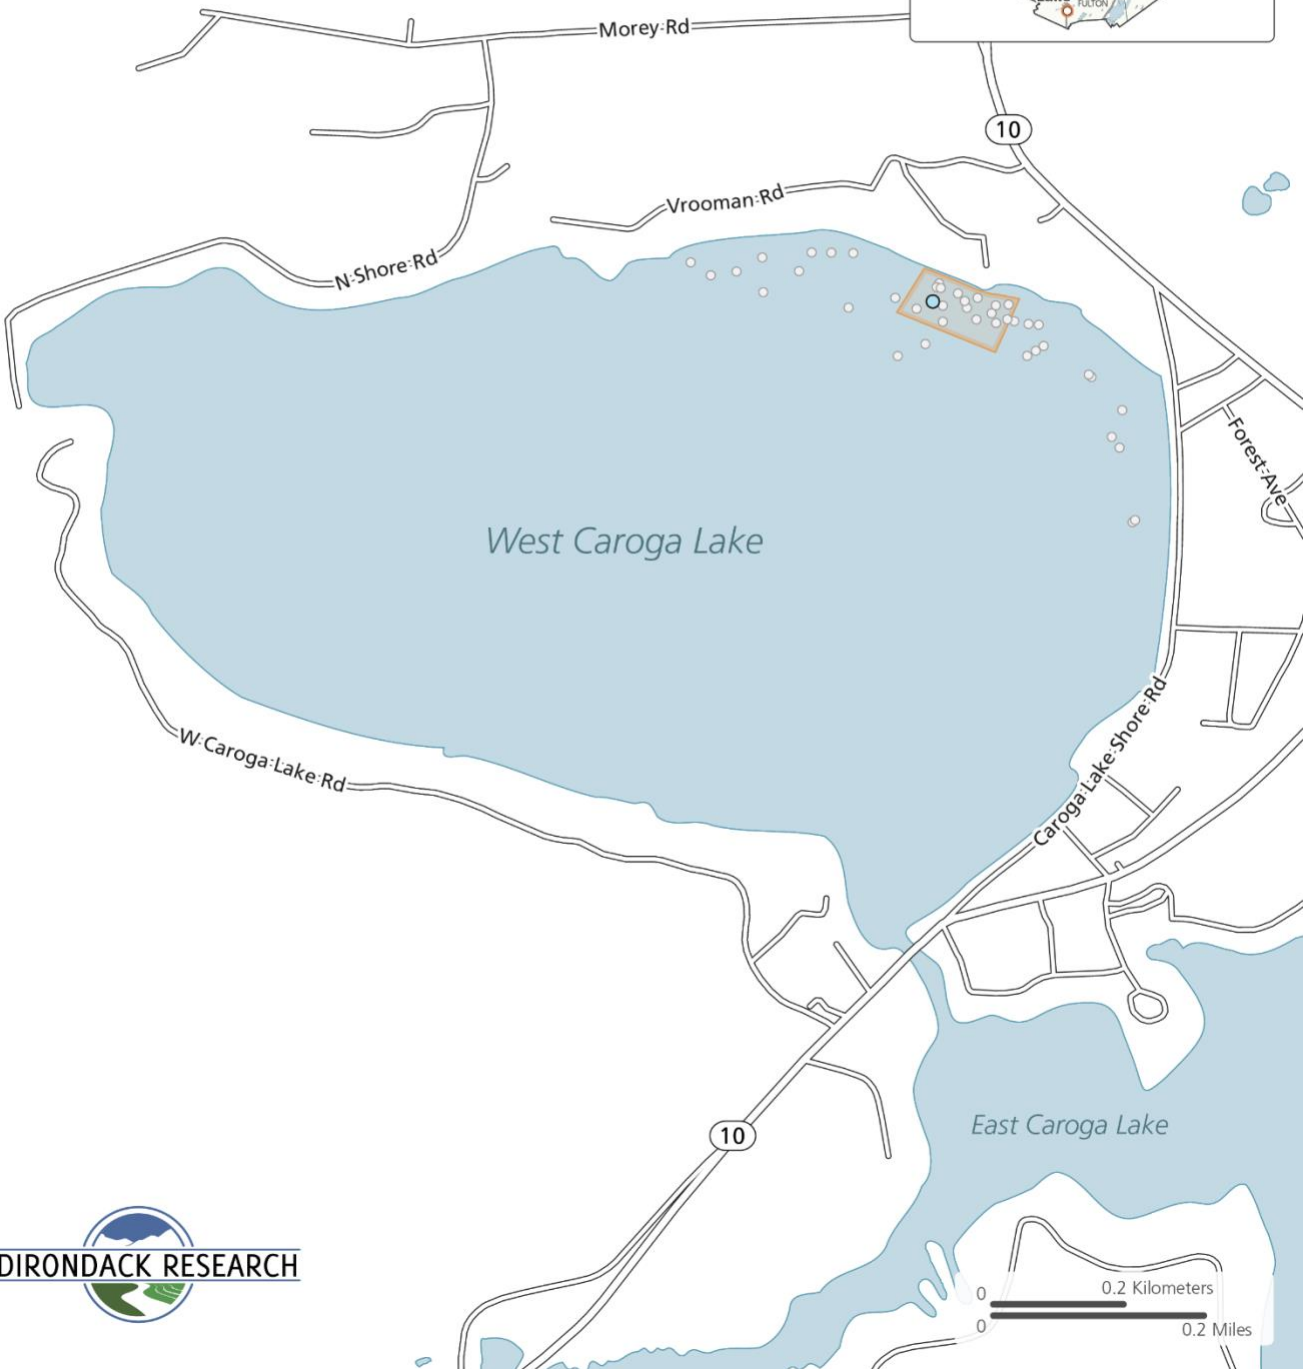
West Caroga Lake
Eelgrass
Vallisnaria americana

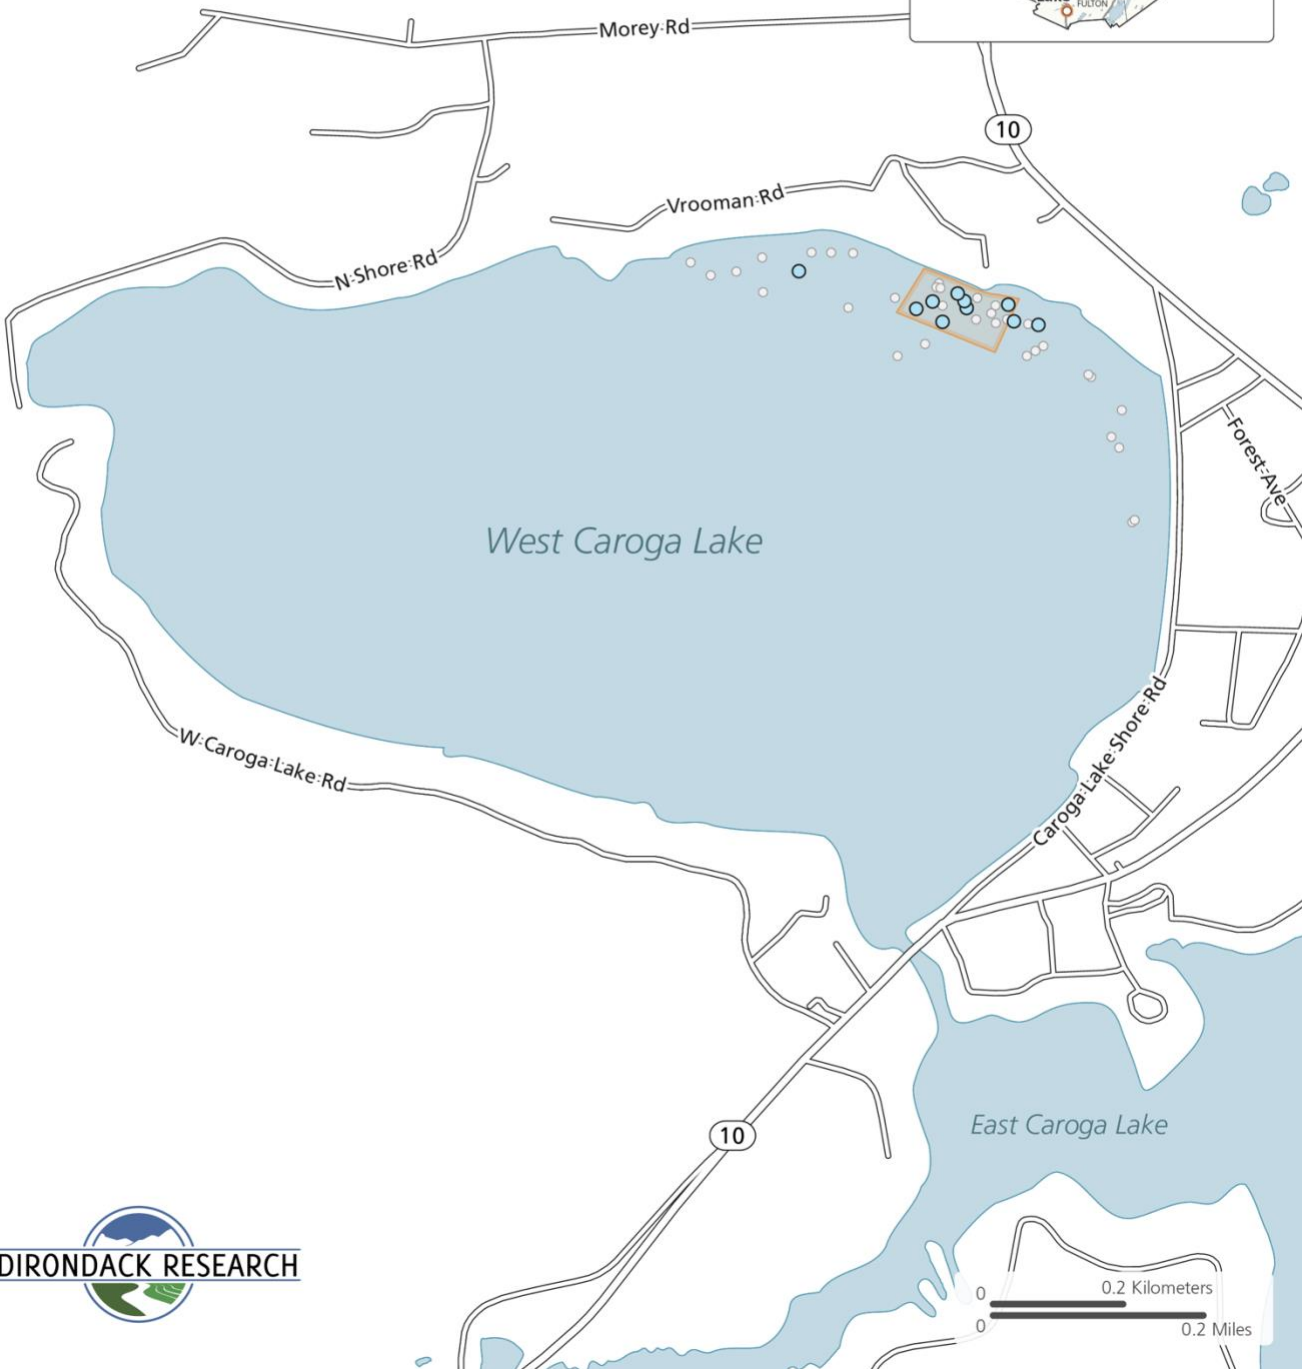
West Caroga Lake

Eurasian Watermilfoil
Myriophyllum spicatum

Eurasian watermilfoil (*Myriophyllum spicatum*): This plant was found at a total of 12 out of 43 stations resulting in 27.91% of occurrences. It was most commonly found growing at 5% - 25% levels, (n=8, 66.67%) followed by less than 5% levels, (n=4, 33.33%).

Of the 12 stations Eurasian watermilfoil was documented, 11 were recorded in the proposed treatment area, and 1 was located outside the proposed treatment area. The majority of occurrences were recorded at the northern portion of the lake. Of the 12 points recorded most found were growing at Sparse levels, (n=8, 66.67%) followed by Trace levels, (n=4, 33.33%). Table 3 displays the station number, respective GPS coordinates and depth that Eurasian watermilfoil was recorded, along with its abundance and the total species richness at that point.

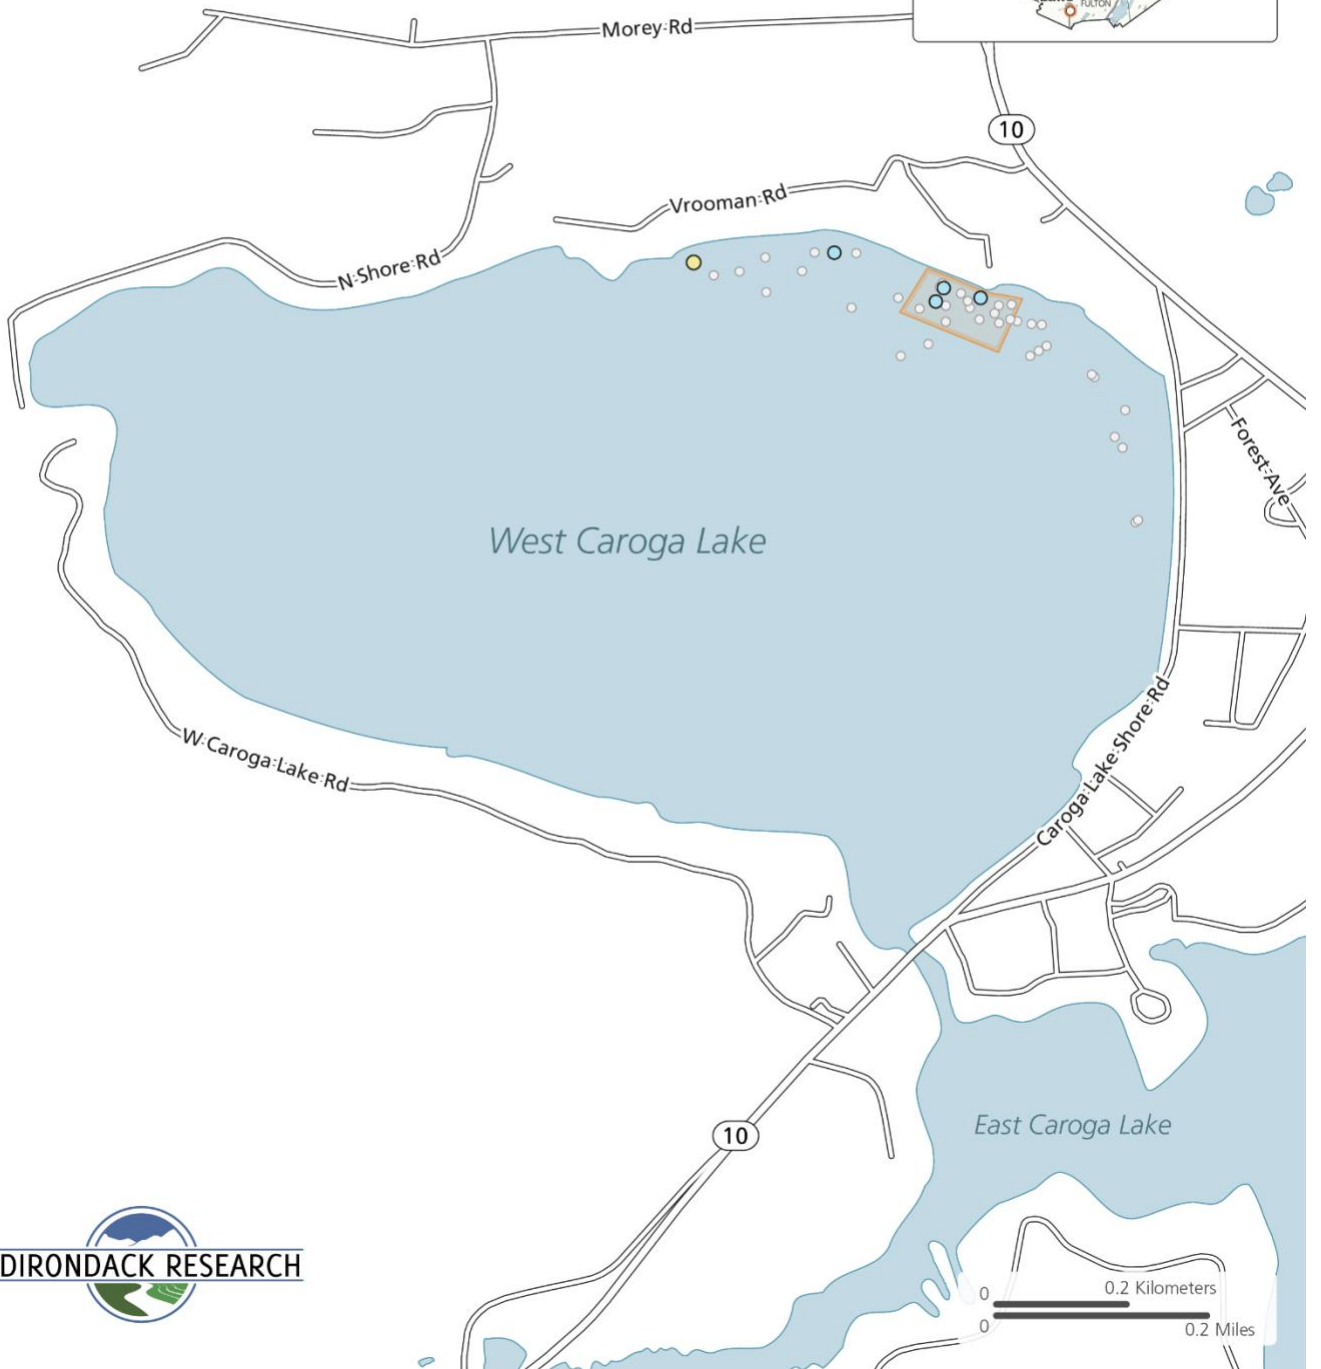
West Caroga Lake

Muskgrass *Chara sp.*

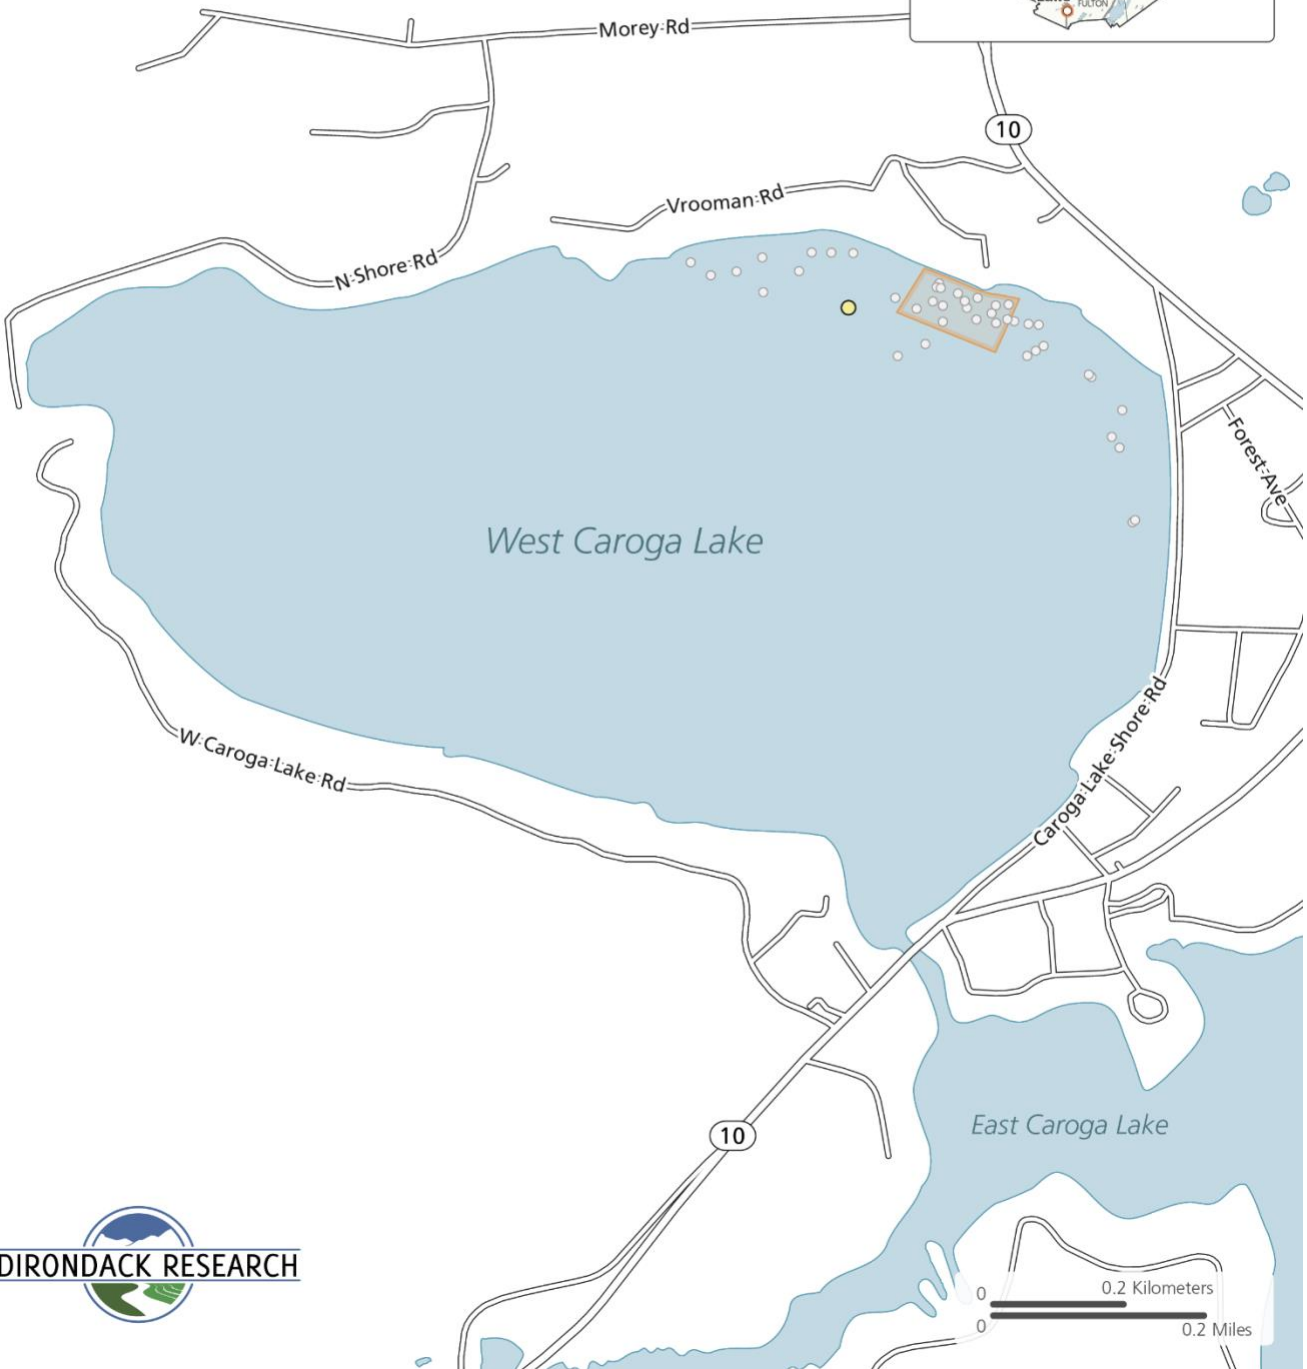
West Caroga Lake

Slender Naiad *Najas flexilis*

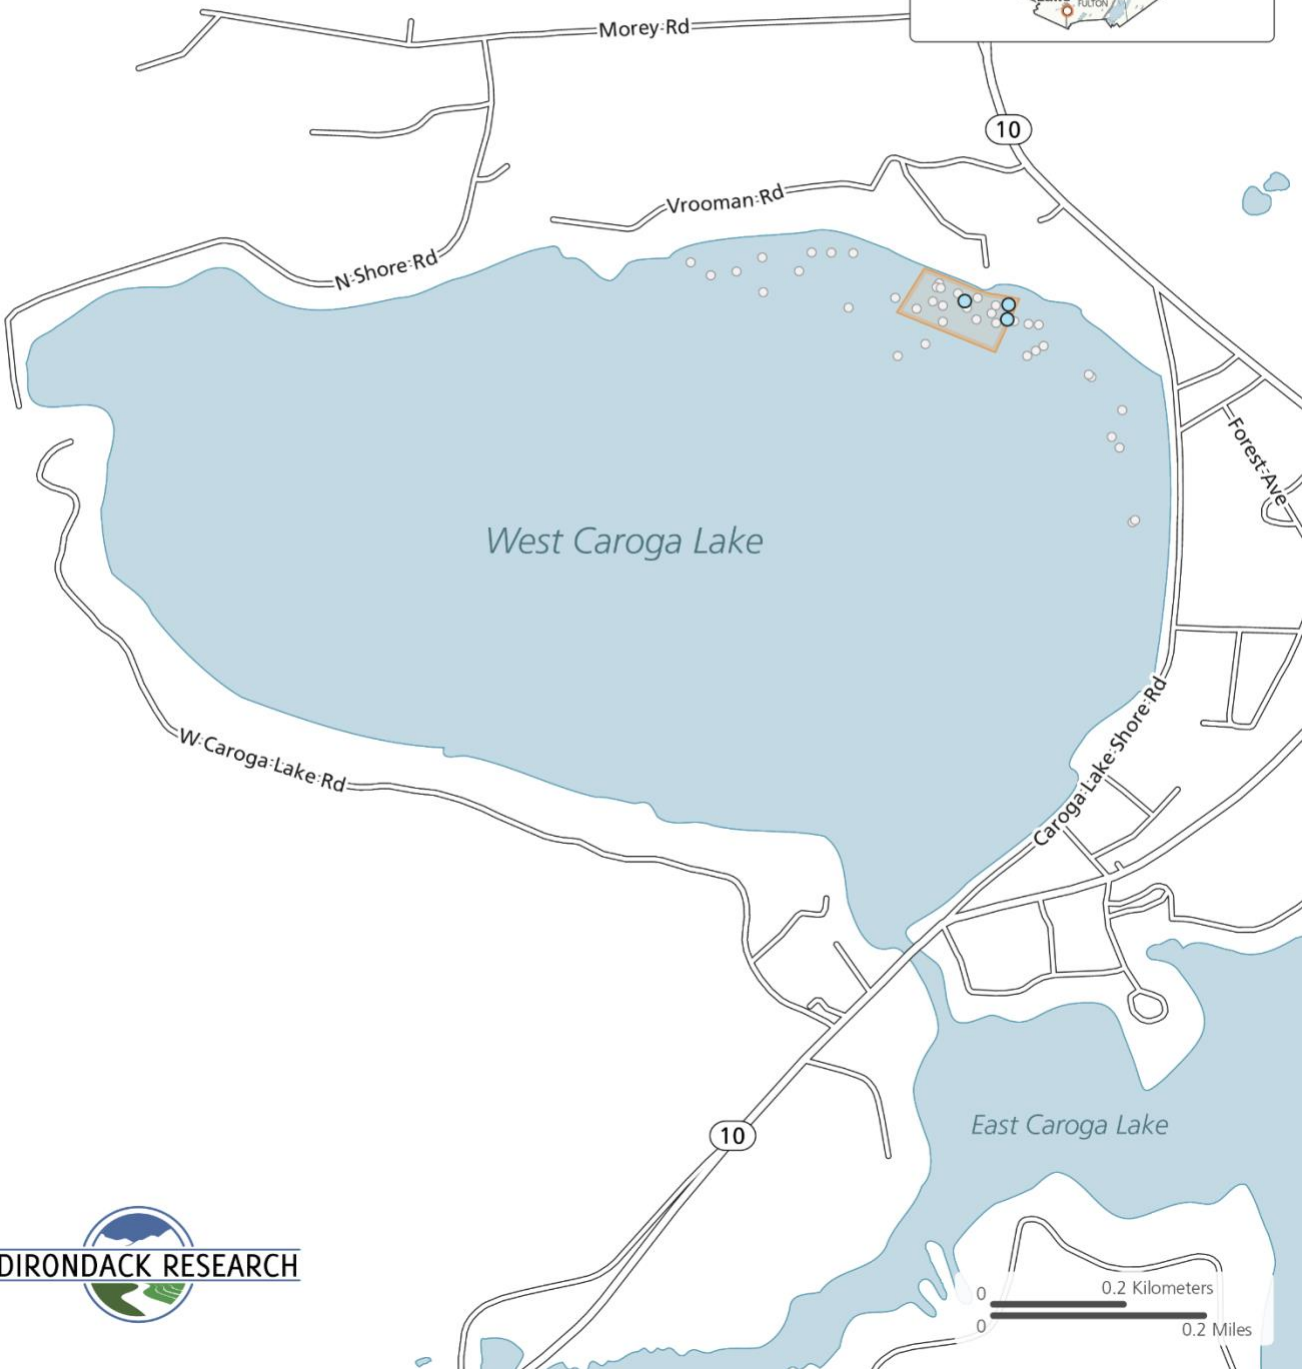
West Caroga Lake

Stonewort *Nitella Sp.*

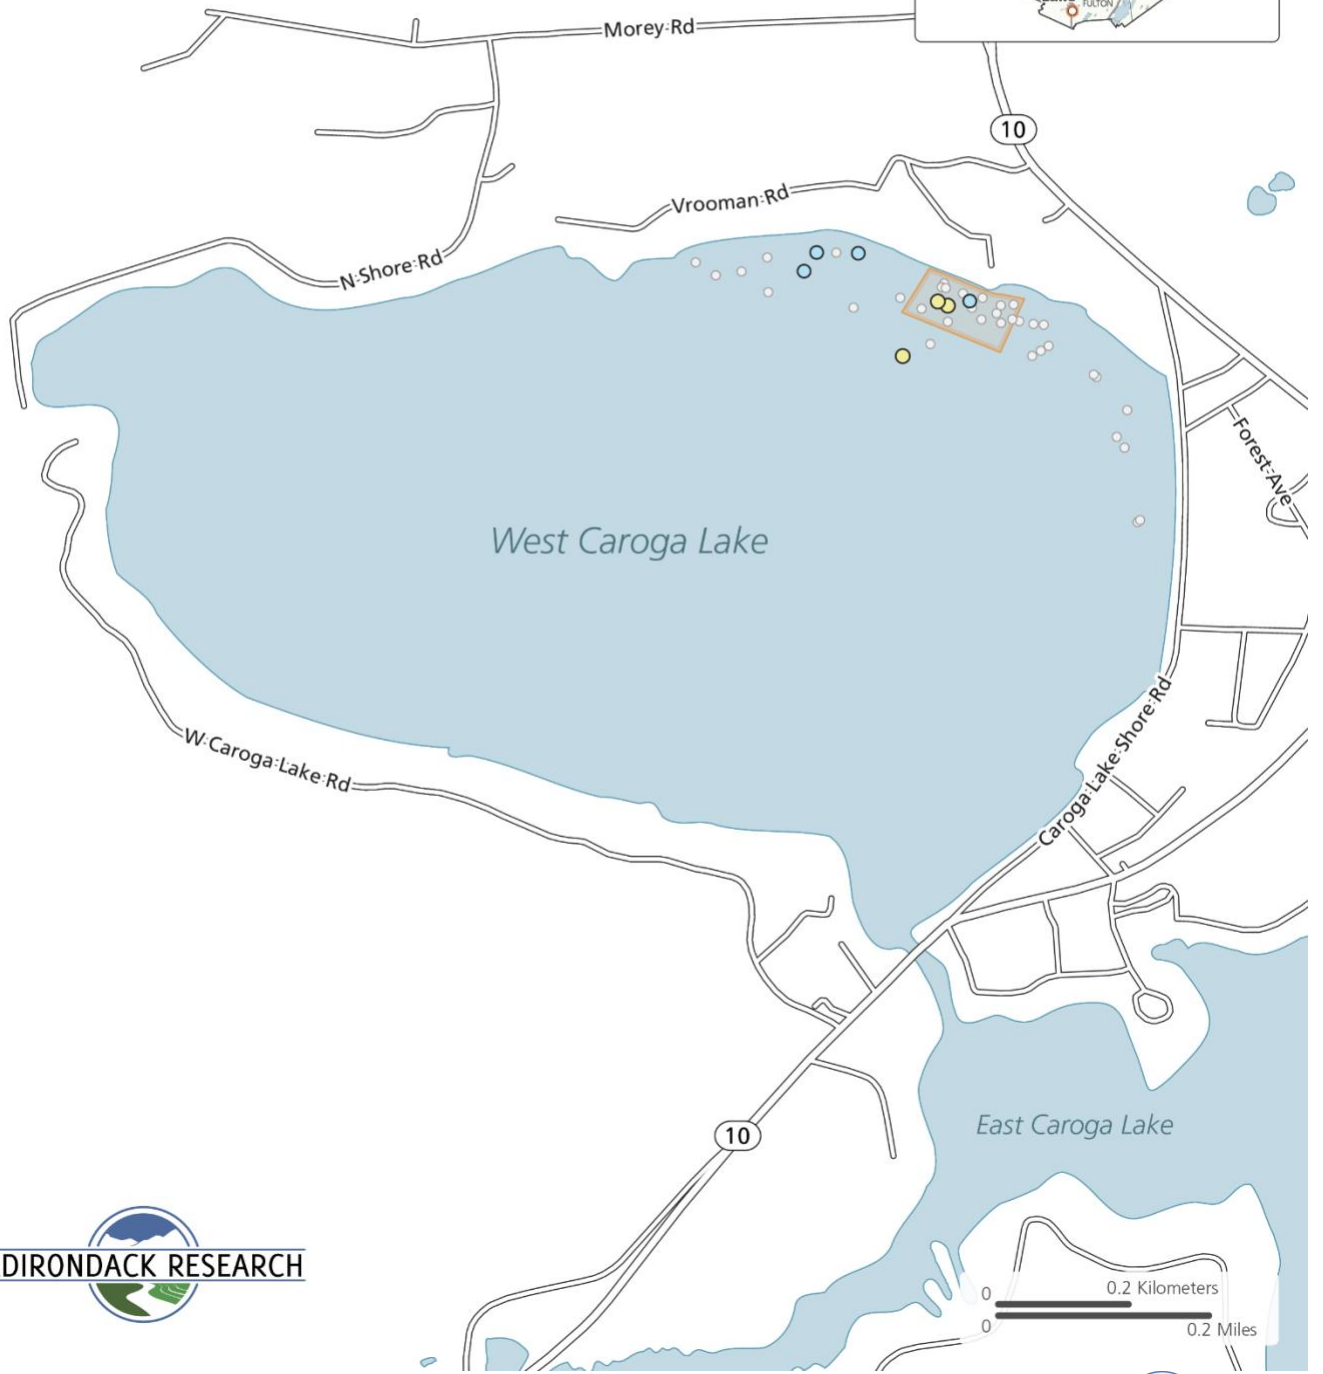
West Caroga Lake
Water Nymph
Najas

Water nymph (*Najas sp.*): This plant was found at a total of 3 out of 43 stations resulting in 6.98% of occurrences. It was most commonly found growing at less than 5% levels, (n=2, 66.67%).

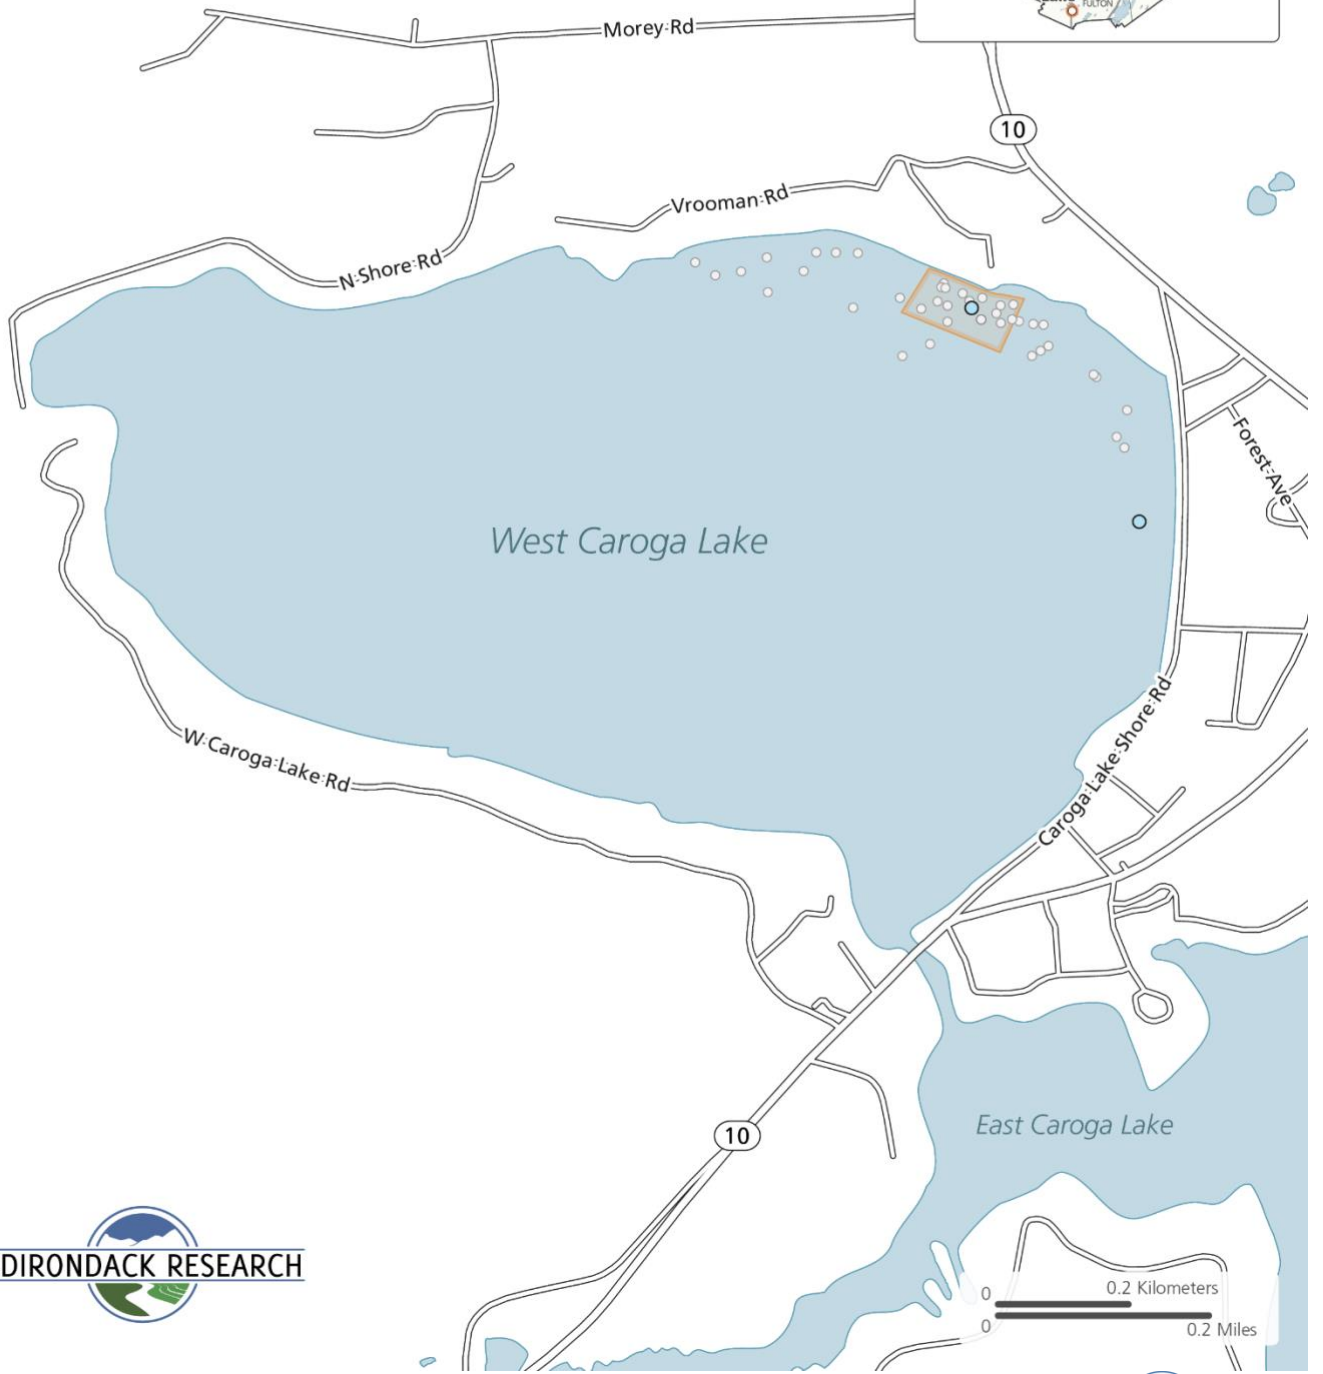
West Caroga Lake

White Stemmed Pondweed *Potamogeton praelongus*
