Minerva Lake 2025 Aquatic Macrophyte Survey Report

Submitted November 6, 2025

Report Prepared by Chris Doyle, CLM

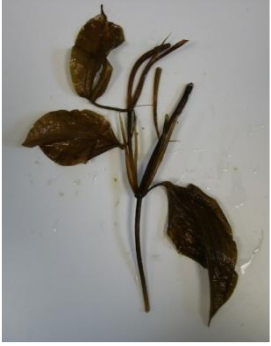
<p>Bassweed</p>

Bassweed is one of eight pondweeds collected in 2025. Minerva Lake boasts a healthy assemblage of desirable pondweeds, and bassweed, with its broad leaves which creates excellent fish habitat, was the most common, occurring at 43% of the sites surveyed. Individual stems of bassweed were also observed in between sampling locations. Most of the sites displayed sparse (60%) bassweed abundance. Trace (17%) and

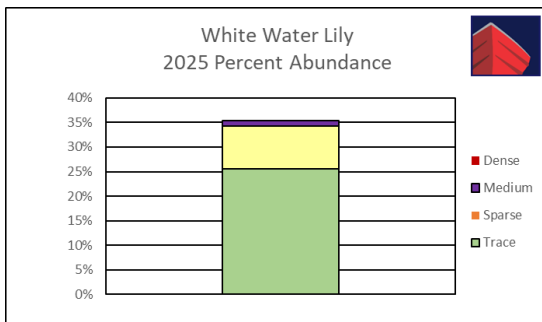
White Water Lily (*Nymphaea odorata*)

White water lily was one of three floating-leaf macrophytes observed during our 2025 survey. It has larger, round pads and produces showy white flowers. It was the most common floating macrophyte, occurring at 29 (or 35%) of the stations. Most of these sites were trace abundance (72%) along with a few sparse (24%) and one (3%) medium site. It was scattered about the basin, but more commonly occurred in the northern cove, in the

northwestern cove, and the southwest cove. The medium site was located in the southwest cove, along the shoreline. White water lily is at non-nuisance abundance at Minerva Lake and is suitable wildlife habitat.

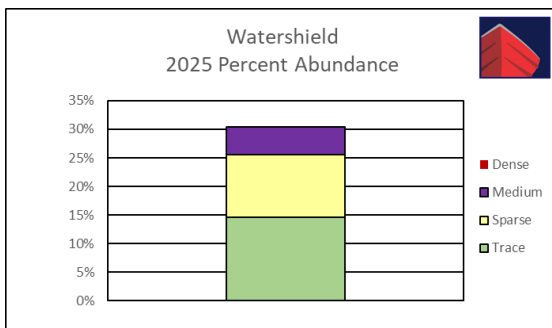
Watershield (*Brasenia schreberi*)

Watershield is the second floating leaf macrophyte collected during the 2025 survey. It has smaller, oval leaves, and the stem is centrally located on the pad. The undersides of the pad and stems are often covered with a gelatinous coating. Watershield occurred at 25 (or 30%) of the sites surveyed. Most of these sites were considered trace or sparse abundance (30% and 48%, respectively) but 4 (or 16%) medium sites were also observed.

Looking at the distribution map, watershield was restricted to the western and northern shorelines.

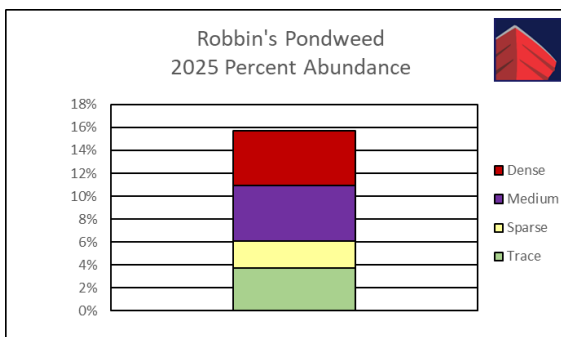
Robbin's Pondweed (*Potamogeton robbinsii*)

Robbin's pondweed is a highly desirable native pondweed that can establish dense low-growing beds that can inhibit other (even invasive species) growth. It rarely reaches the surface or becomes a nuisance to most lake uses, and is excellent invertebrate habitat. Robbin's pondweed occurred at 13 (or 16%) of the sites surveyed, but in a full range of abundances. It occurred at trace (16%), sparse (23%), medium (15%) and even

in some of those dense beds (31%). It occurred in the open water (two medium sites), along the northern shoreline (including three dense and one medium sites), plus isolated locations along the east and west shorelines.

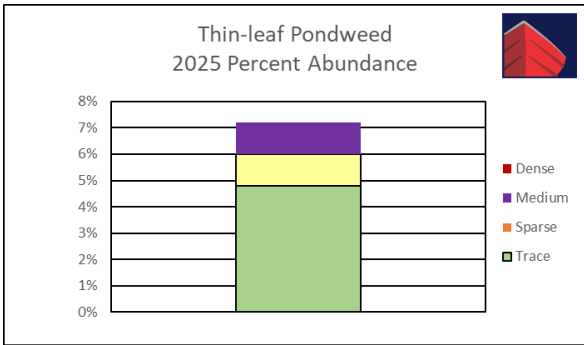
Thin-leaf Pondweed (*Potamogeton* sp.)

When a thin-leaf pondweed lacks distinguishing characteristics, such as seeds or floating leaves, we assign it to thin-leaf pondweed. The specimens were probably small pondweed (*P. pusillus*), a muddled grouping of thin-leaf pondweeds, or Berchtold's pondweed (*P. berchtoldii*) both of which have been collect at this site in the past. Thin-leaf pondweed occurred at 6 (or 7%) of the sites surveyed. Most

were trace abundance (67%) but single sites of sparse and medium abundance also were collected. It was scattered throughout the basin, with the medium site being located in the southwest cove.

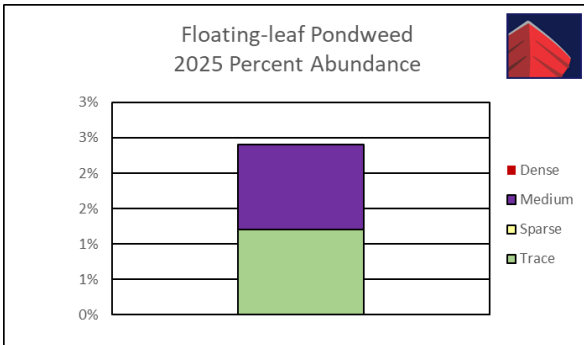
Floating-leaf Pondweed (*Potamogeton natans*)

Floating-leaf pondweed is an uncommon pondweed with reduced (or none) submersed leaves. Instead, it produces oval floating leaves and is often intermixed with other floating leaf macrophytes (such as lilies and watershield). Floating-leaf pondweed was collected at two locations during the 2025 survey. One station was trace abundance (located in the northern cove) and the other was medium abundance (located in the southwestern cove. Since we could not access station

#71 in the northern cove (due to water level and macrophyte growth at the surface), it stands to reason that more floating-leaf pondweed is found at and around that location.
